MIDDLE EAST TECHNICAL UNIVERSITY

Preliminary Reconnaissance Report on February 6, 2023, Pazarcık $M_w=7.7$ and Elbistan $M_w=7.6$, Kahramanmaraş-Türkiye Earthquakes

REPORT NO: METU/EERC 2023-01

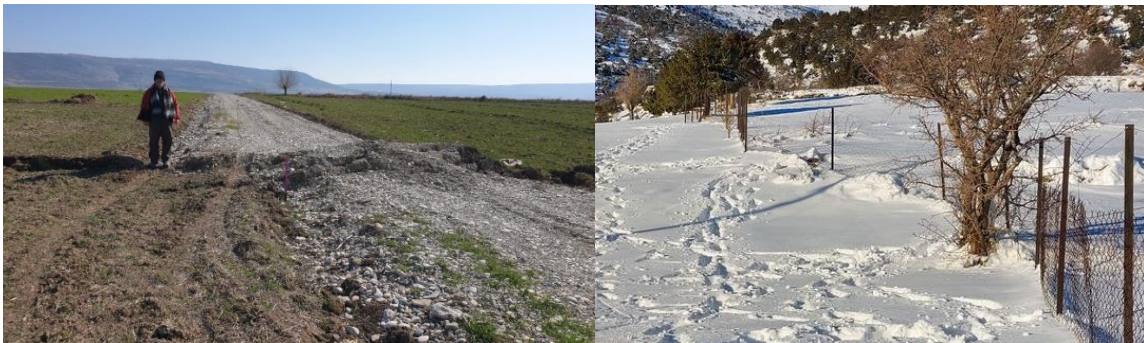
Figure 2.2. Photos of 2.4 m road offset near Pazarcık and 6.7 m fence offset along the Sürgü-Çardak fault segment (taken by Erdin Bozkurt and Taylan Sançar respectively).

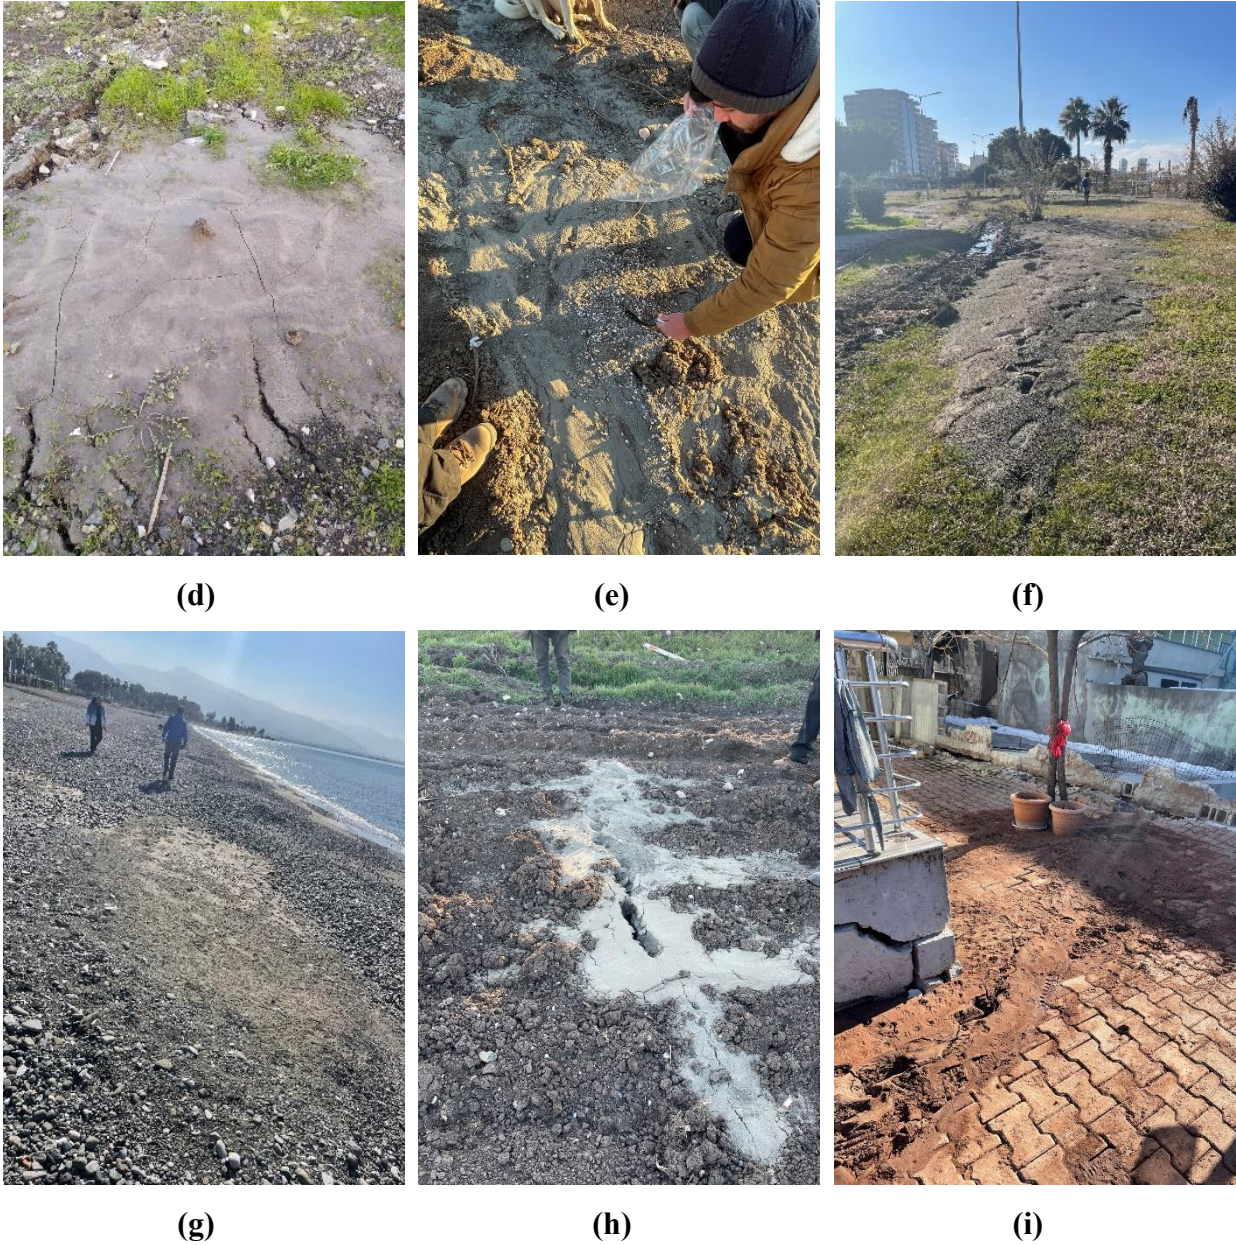
The liquefaction phenomena were widely observed in Hatay-Paşaköy, Hatay-İskenderun, Adıyaman-Gölbaşı, Adıyaman-Türkoğlu regions. Lateral spreading and subsidence were accompanied to liquefaction triggering at these sites.

Figure 4.1. Seismic soil liquefaction-induced surface manifestation: sand boils in free field conditions: **a)** Hatay ($36.36446^\circ N, 36.28147^\circ E$), **b)** Kumlu / Hatay ($36.35628^\circ N, 36.39360^\circ E$), **c)** Fatih District / Gölbaşı / Adıyaman ($37.78080^\circ N, 37.62888^\circ E$), **d)** İskenderun / Hatay ($36.59323^\circ N, 36.18542^\circ E$), **e)** Emiroğlu / Kahramanmaraş ($37.33689^\circ N, 37.04538^\circ E$), **f)** Çay District / İskenderun / Hatay ($36.59133^\circ N, 36.17888^\circ E$) **g)** Dört Yol / Hatay ($36.81878^\circ N, 37.17770^\circ E$) **h)** Emiroğlu / Kahramanmaraş ($37.33722^\circ N, 37.04549^\circ E$) **i)** Gölbaşı / Adıyaman ($37.78655^\circ N, 37.63155^\circ E$)

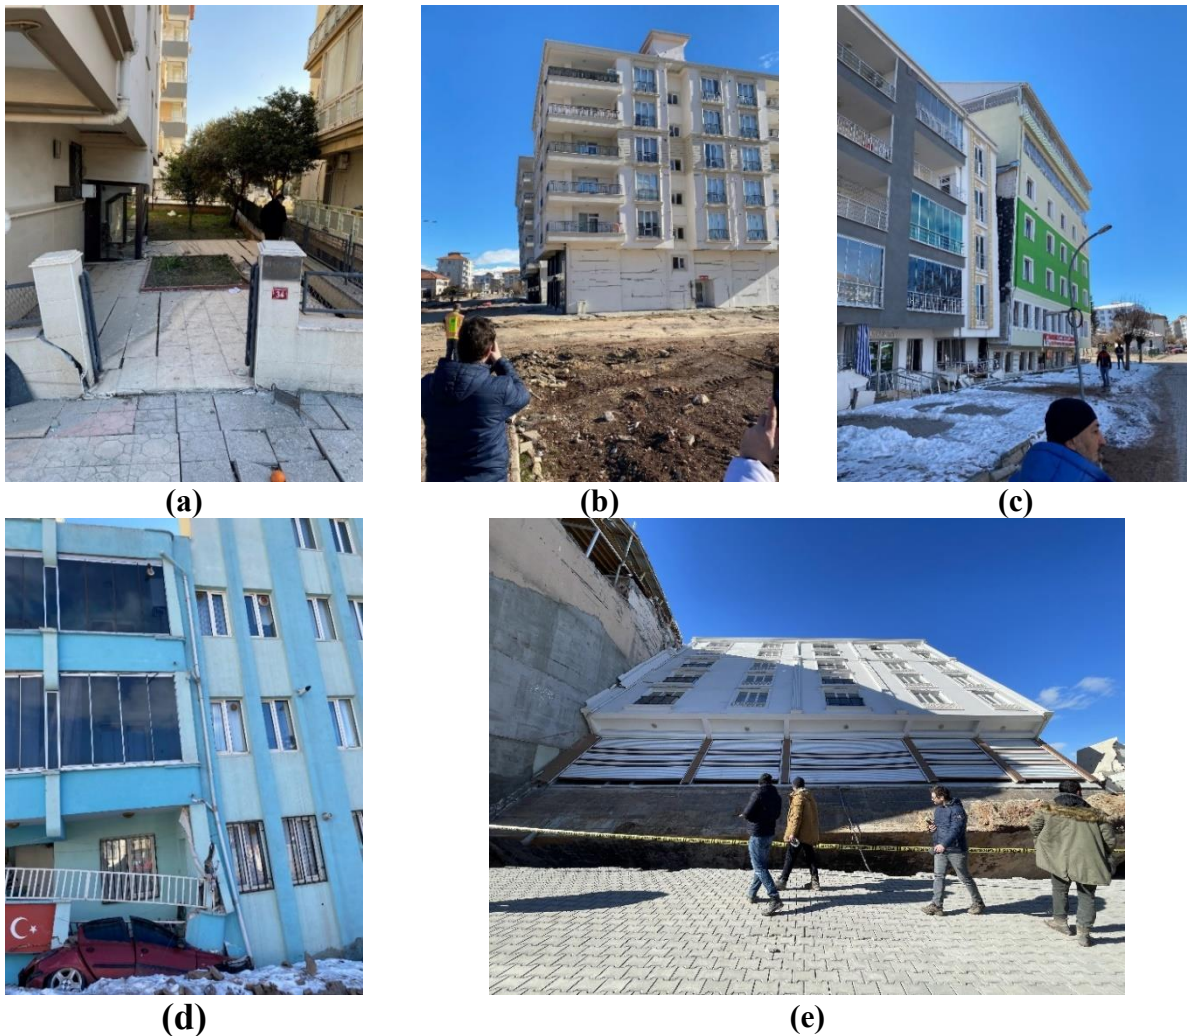
Many residential building foundations in Hatay-İskenderun, and Adıyaman-Gölbaşı regions were subjected to excessive settlements and bearing capacity failures due to seismic soil liquefaction initiation. The extent of these foundation settlements varies in the range of a couple of centimeters to an excess of 80 cm. Moreover, differential settlements reach 30 cm, causing 5 to 10 degree tilting of buildings. An extreme case of liquefaction-induced bearing capacity failure and toppling of a residential building in Adıyaman-Gölbaşı is shown in Figure 4.4 (e). Raft foundation thickness of this building is measured as 80 cm.

Figure 4.4. Poor foundation performance in **a)** Çay District / İskenderun / Hatay ($36.5911^{\circ}N$, $36.1790^{\circ}E$), **b)** Hüriyet District / Gölbaşı / Adıyaman ($37.778^{\circ}N$ $37.628^{\circ}E$), **c)** Yavuz Selim District / Gölbaşı / Adıyaman ($37.788^{\circ}N$, $37.642^{\circ}E$), **d)** Yavuz Selim District / Gölbaşı / Adıyaman ($37.788^{\circ}N$, $37.642^{\circ}E$), **e)** Yavuz Selim District / Gölbaşı / Adıyaman ($37.78827^{\circ}N$ $37.64879^{\circ}E$)

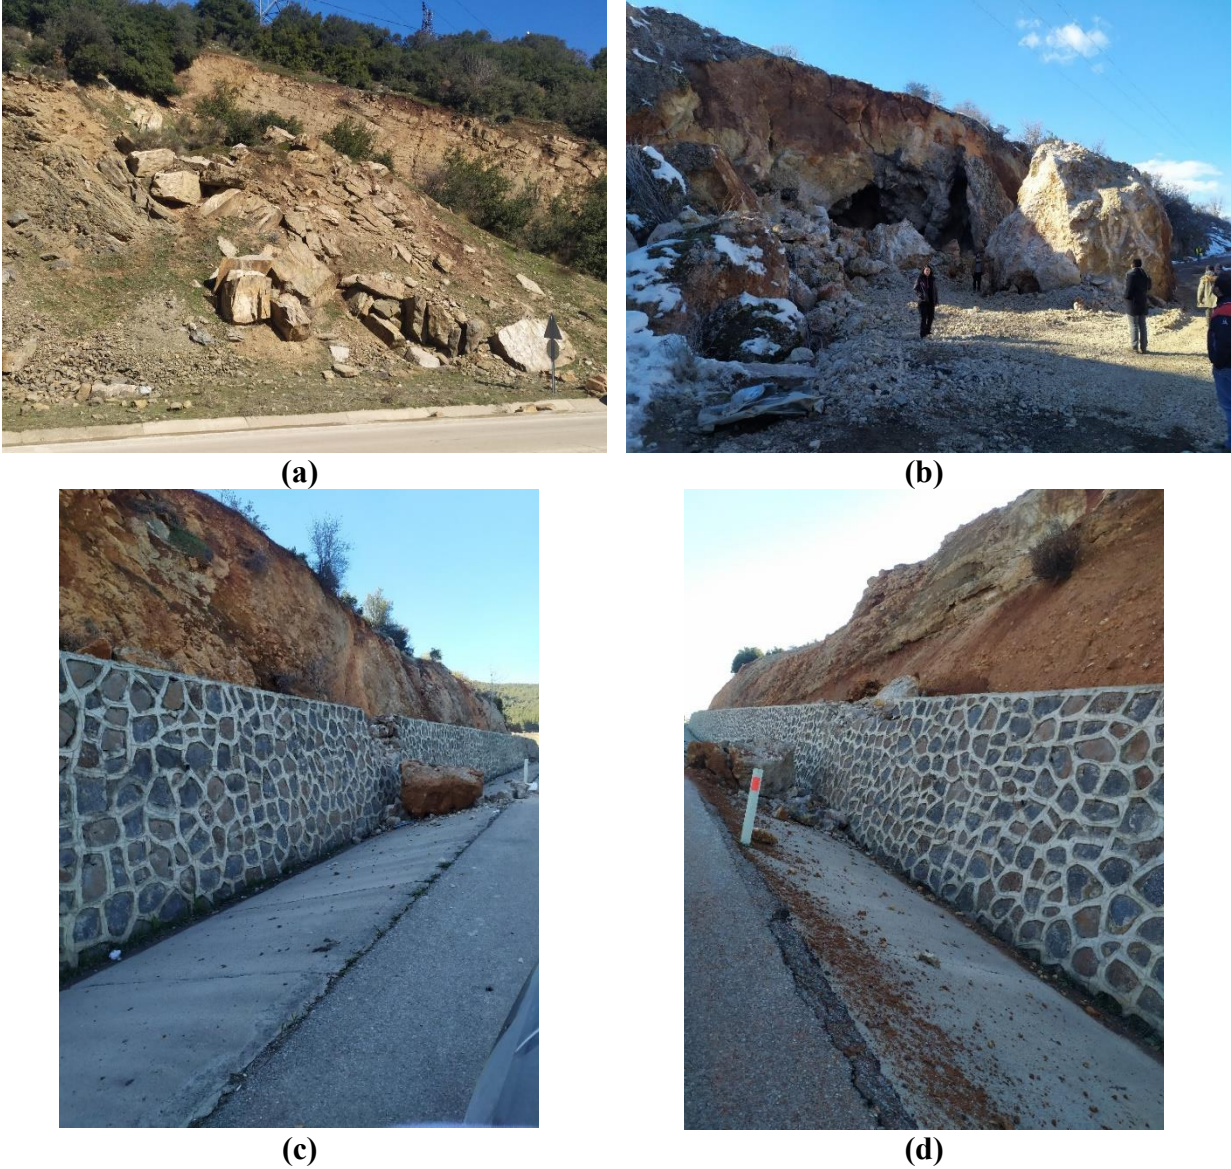
Several rockfalls were observed by the benches of highways and some examples are shown in Figures 4.7 (a) through (d).

Figure 4.7. Some examples of rockfalls in **a)** Bahçe / Osmaniye ($37.17441^{\circ}N, 36.65659^{\circ}E$), **b)** Yolbağı District / Adıyaman ($37.81795^{\circ}N, 37.63311^{\circ}E$), **c)** Fevzi Paşa District / İslahiye /Gaziantep ($37.09899^{\circ} N, 36.65200^{\circ} E$), **d)** Fevzi Paşa District / İslahiye /Gaziantep ($37.09713^{\circ} N, 36.65170^{\circ} E$)

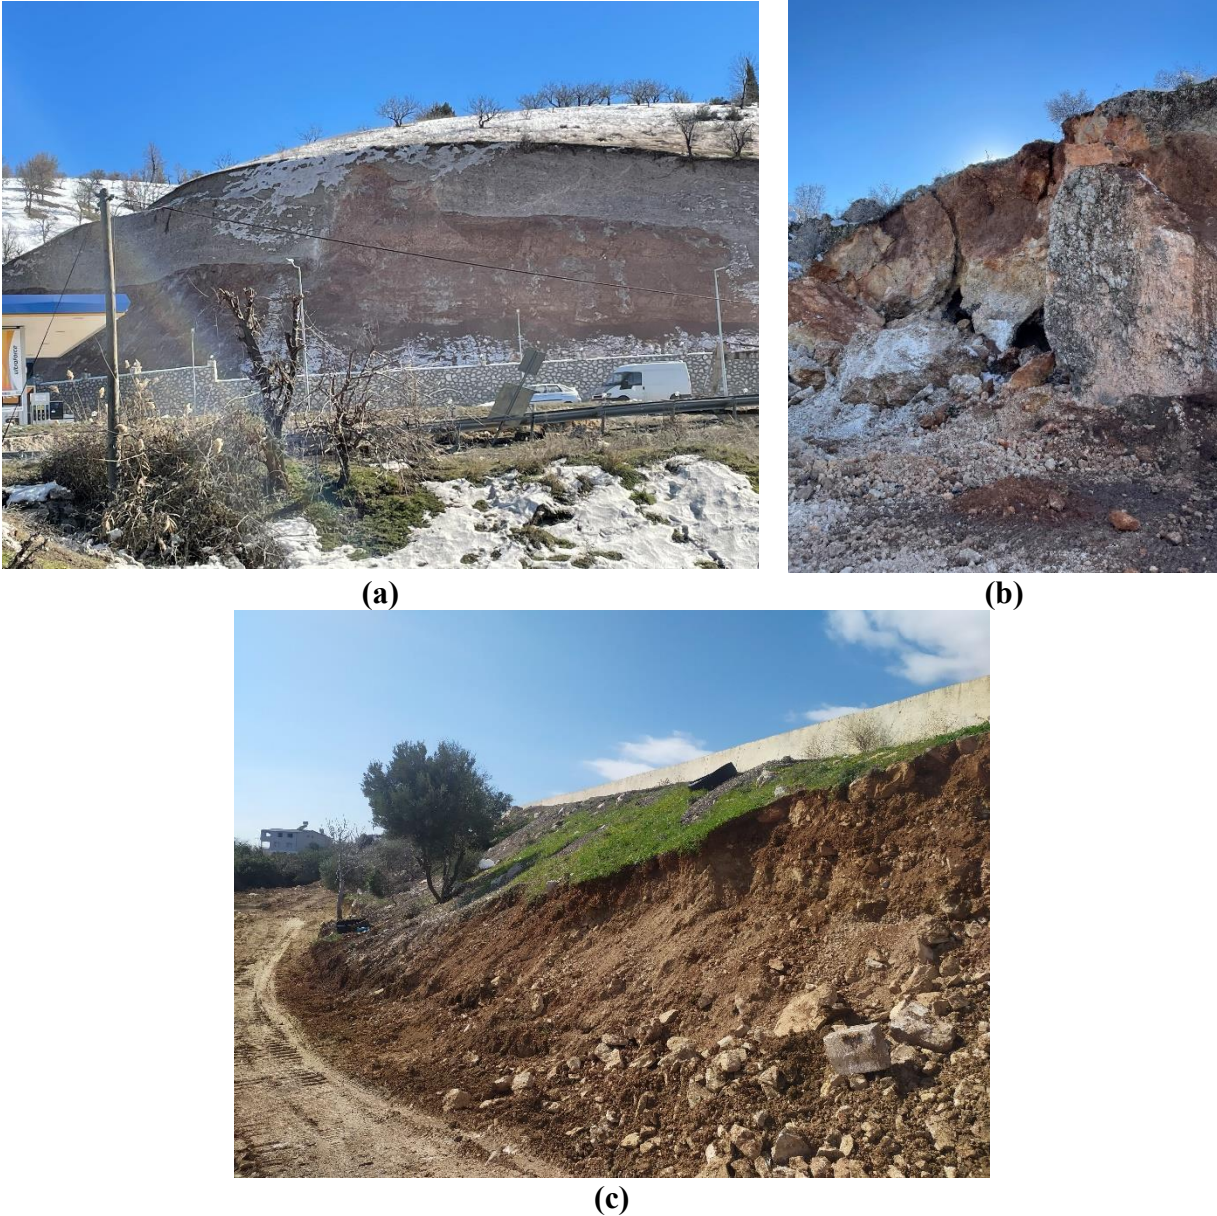
Several landslides with dimensions varying from a scale of a couple of meters to hundreds of meters were documented as part of reconnaissance studies. Some of these are shown in Figures 4.9 (a) through (c).

Figure 4.9. Some examples of slope stability problems in **a)** Gölbaşı/ Adıyaman ($37.79783^{\circ}N$, $37.66232^{\circ}E$), **b)** Yolbağı District / Adıyaman ($37.81806^{\circ}N$, $37.63297^{\circ}E$), **c)** Belen / Hatay ($36.48363^{\circ}N$, $36.27158^{\circ}E$)

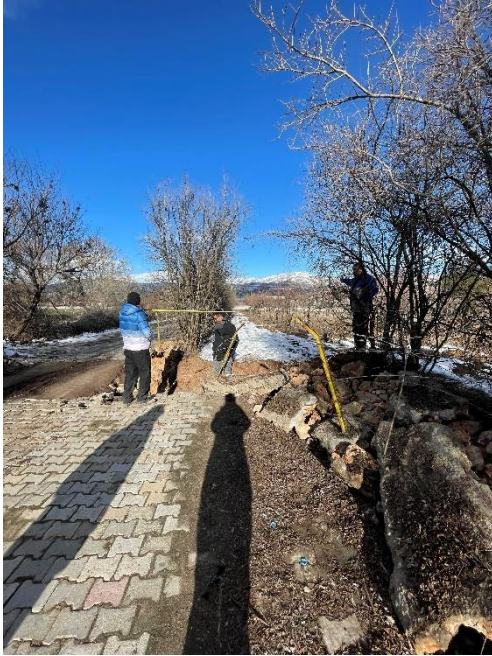
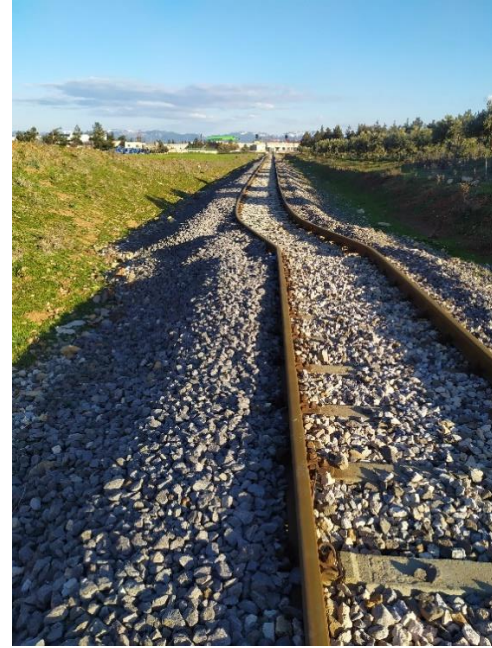
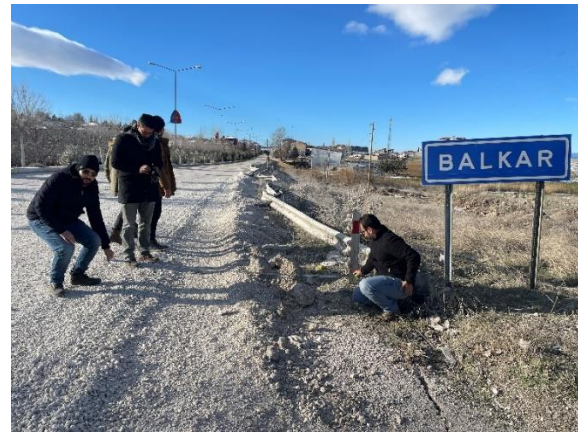
Along the route, several ground deformations either due to primary, secondary, or tertiary faulting or due to seismic soil liquefaction were mapped. Figures 4.10 (a) through (d) display these ground deformations.

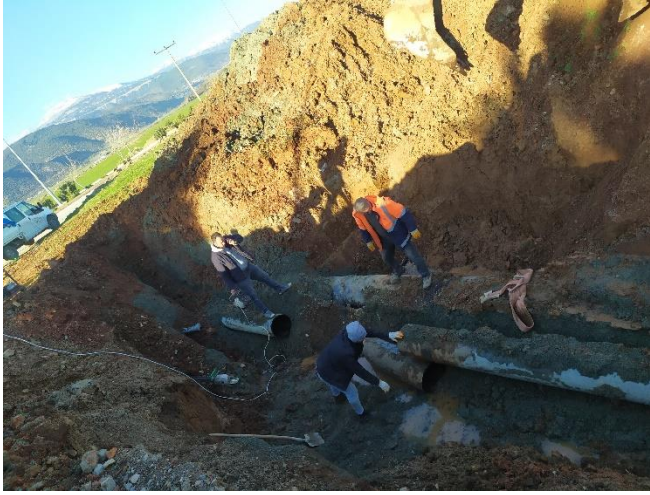
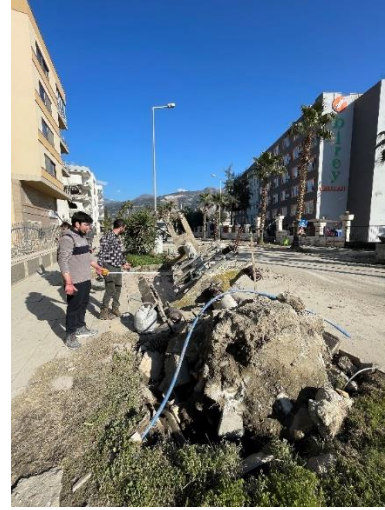
Pipelines were observed to be damaged after the earthquakes and some examples of the damaged pipeline and cables are shown in Figures 4.11 (a) and (b).

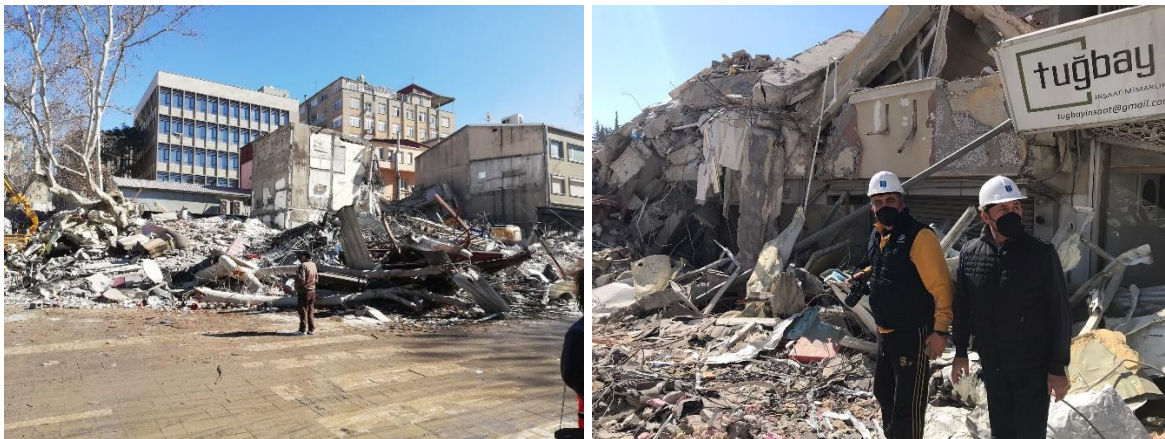
Figure 5.1. Building Collapse in Antakya and Kahramanmaraş

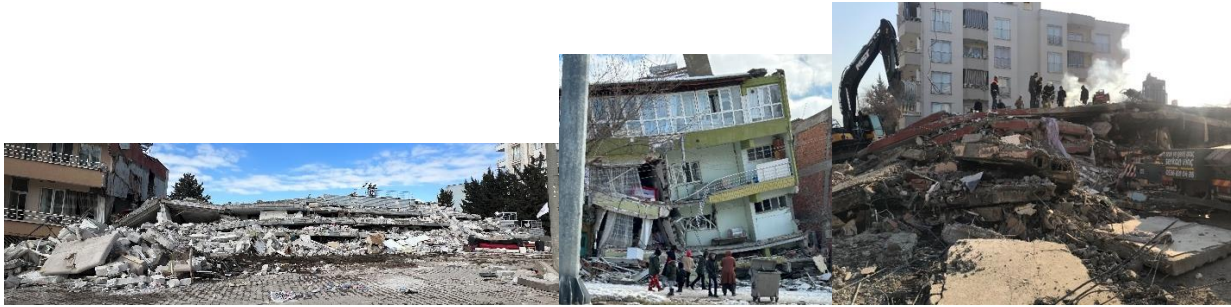
Figure 5.2. Building Collapse in Malatya

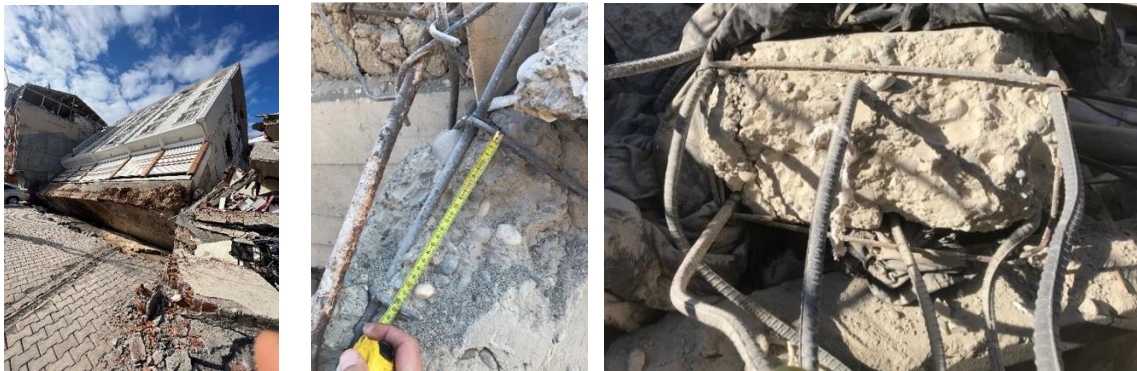
Typical deficiencies of the frame buildings constructed before 2000 were the use of smooth reinforcing bars, insufficient steel reinforcement detailing and possibly low concrete strength resulting in heavy damage and collapse (Figure 5.1). The presence of soft story in the ground level or above the plinth was one of the key reasons of collapse in many buildings. The use of the ground floors as commercial stores with little or no infill walls were responsible for plastic hinging in columns occurred resulting in pancake type collapse as observed in previous earthquakes (Kocaeli 1999, Van 2011). This is displayed in Figure 5.2. Several buildings have experienced beam-column joint failures. Another interesting type of failure was the overturning of the building from its base due the inability of transferring lateral forces to the foundation (Figure 5.3).

Figure 5.3. Overturning due to soil liquefaction and insufficient joint reinforcement detailing

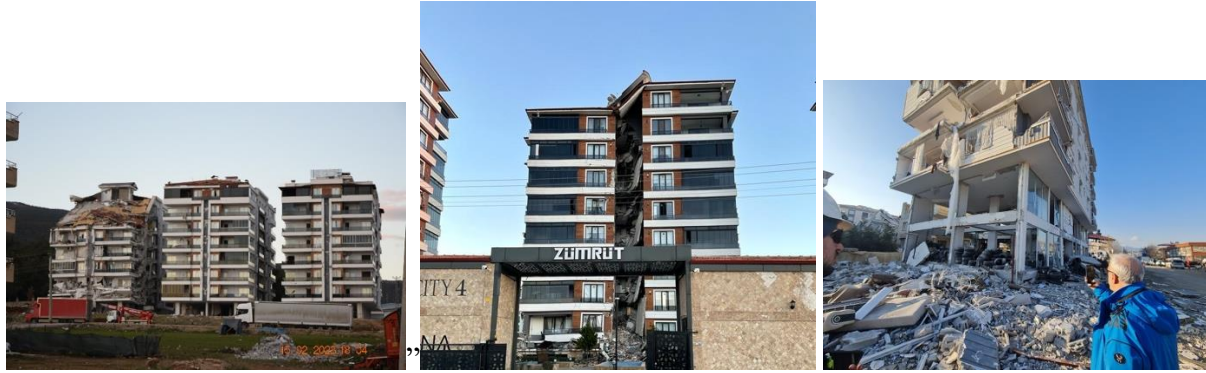
Figure 5.4. Heavily damaged new buildings in Adıyaman and İslahiye

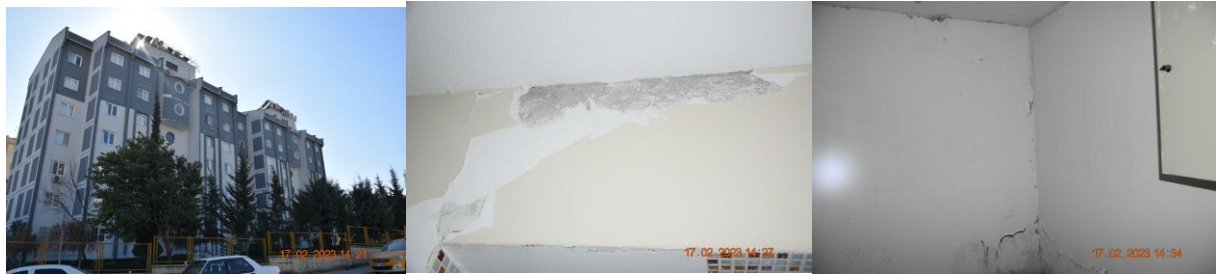
Tunnel form buildings in the region performed in an outstanding manner (Figure 5.5) with some damage in the coupling beams and infill walls due to the following key reasons: i) the use of more shear wall area more than usually 2.5% of the floor area, ii) siting at stiff soil or rock sites, iii) mid-rise construction ranging from (4 to 8 stories). This performance provided further confidence in the use of significant shear wall area for the buildings constructed in high seismic zones.

Figure 5.5. Performance of a tunnel form building

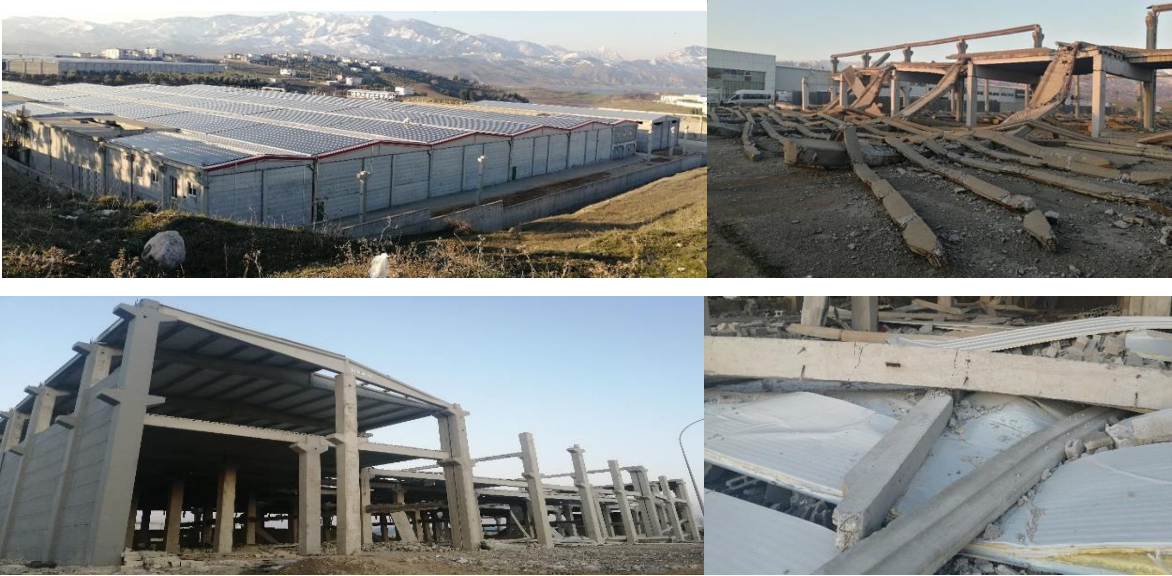
Figure 5.6. Overview of precast industrial building connection damage in Kahramanmaraş

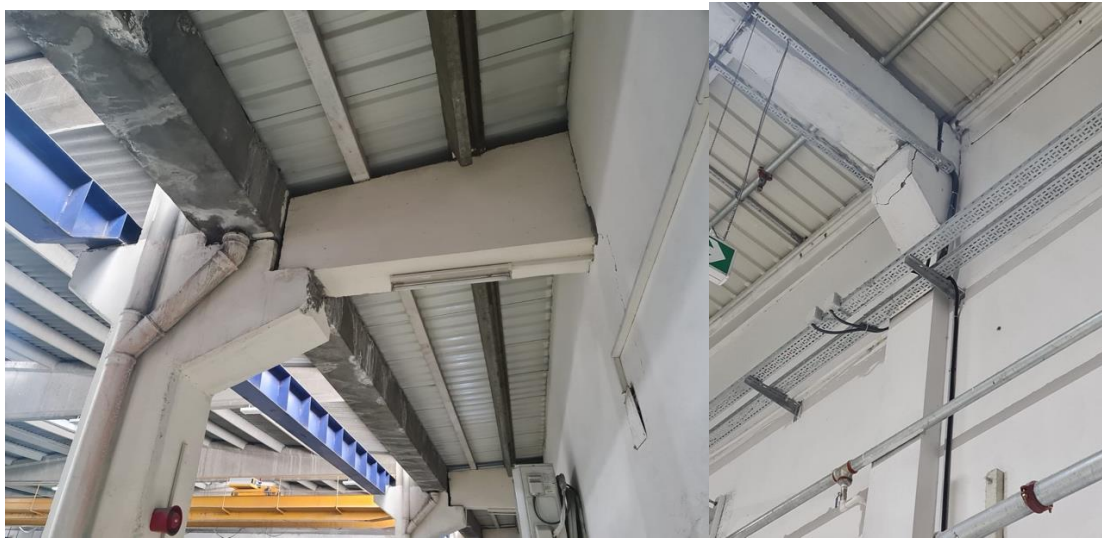
In a few lightly damaged buildings, the typical damage was observed in column corbels due to the girder rotations causing local crushing of concrete, which is repairable (Figure 5.7).

Figure 5.7. Corbel damages in Gaziantep

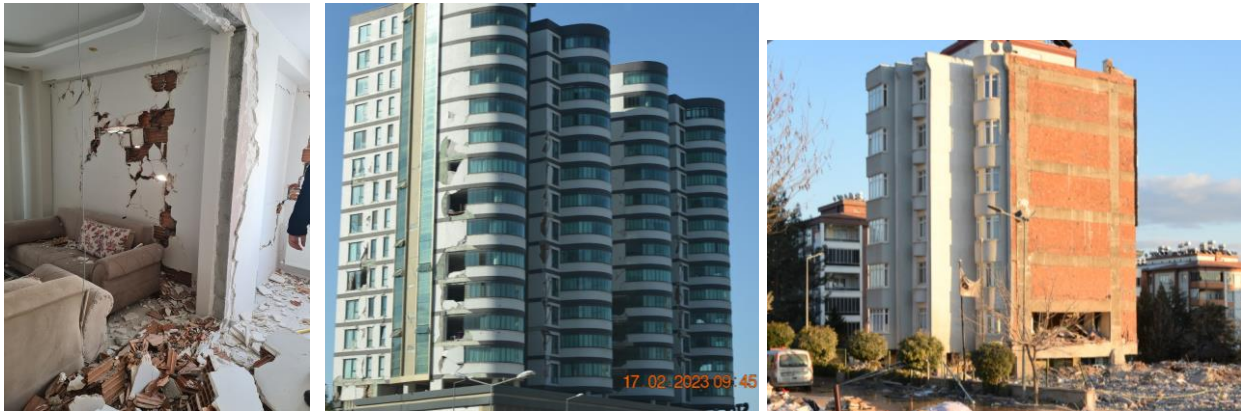
Figure 5.8. Infill wall damage examples

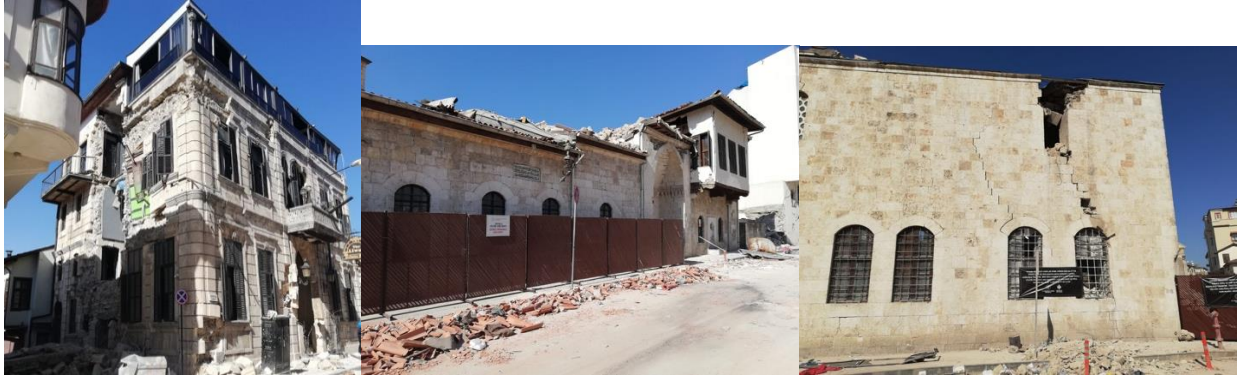
Figure 5.9. Damage in masonry structures

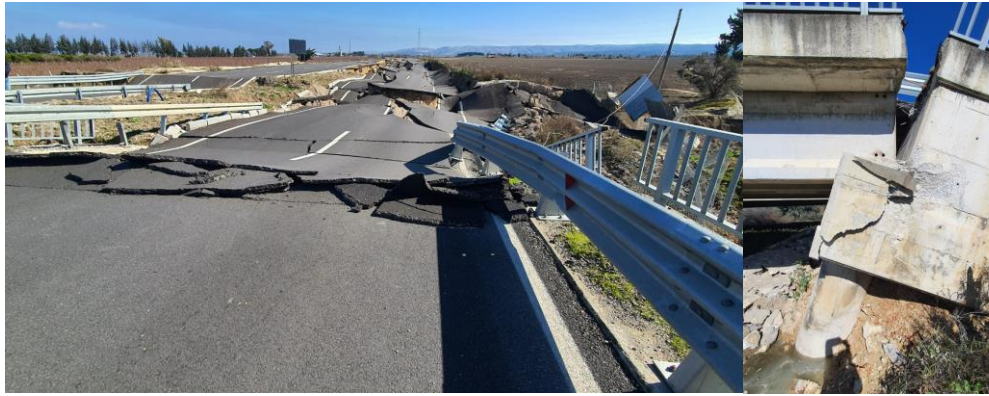
Figure 6.1. Abutment rotation due to seismic soil liquefaction induced foundation failure

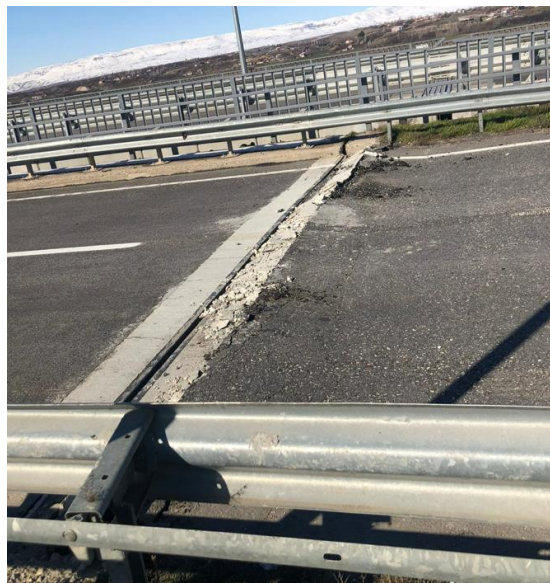
Figure 6.2. Joint movements

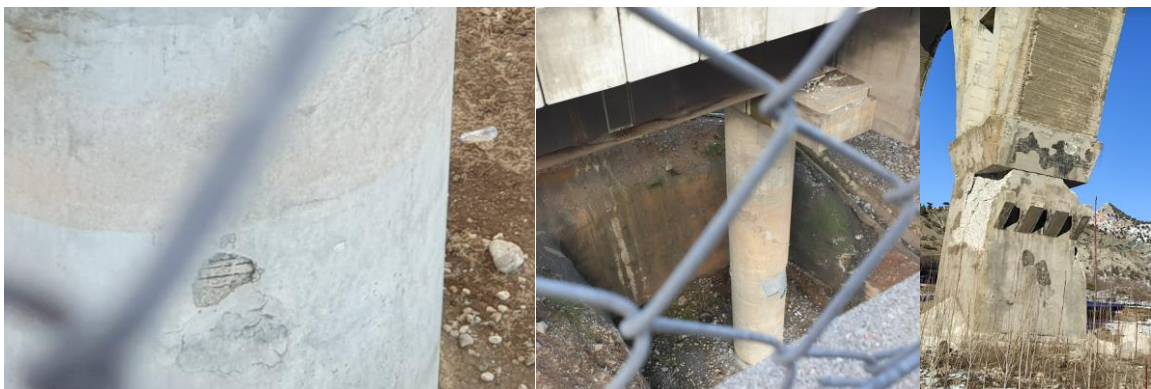
Figure 6.3. Concrete spalling

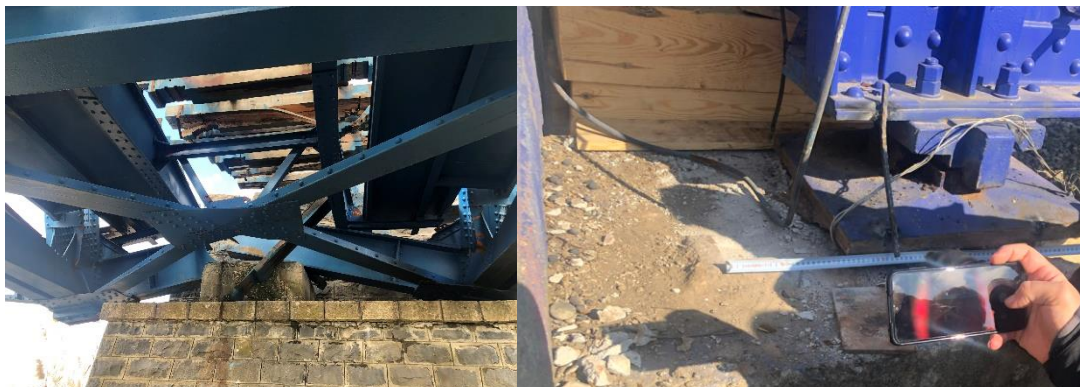
Figure 6.4. Bearing dislocation and movement

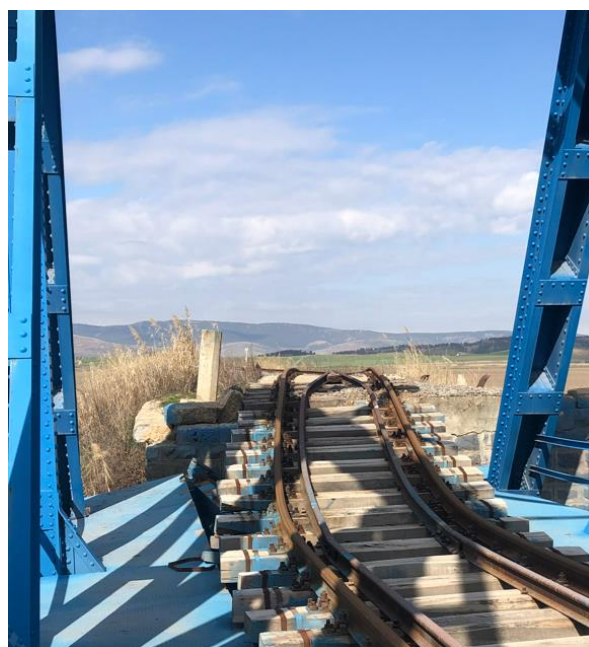
Figure 6.5. Rail misalignment

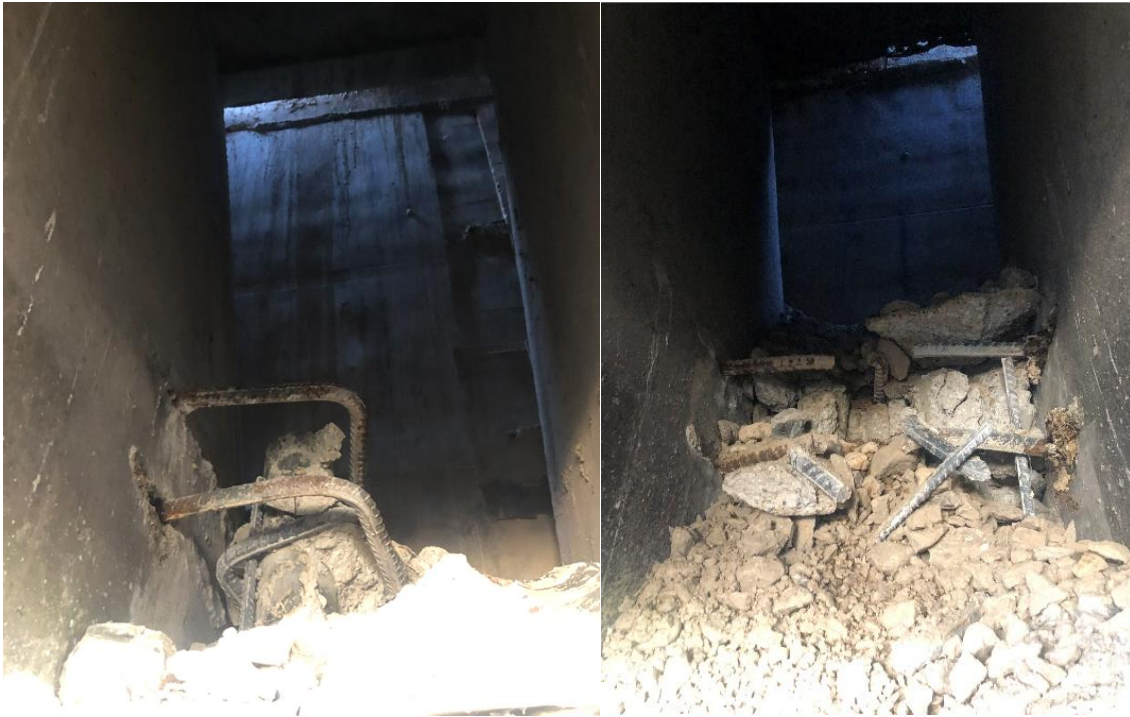
Figure 6.6. Shear key damage

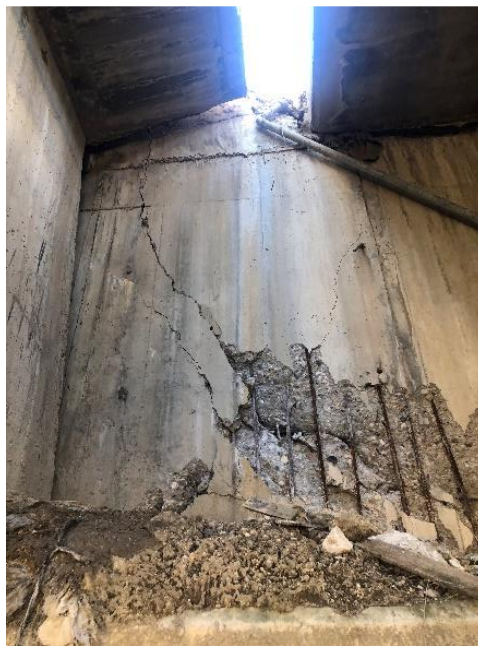
Figure 6.7. Abutment wall concrete spalling

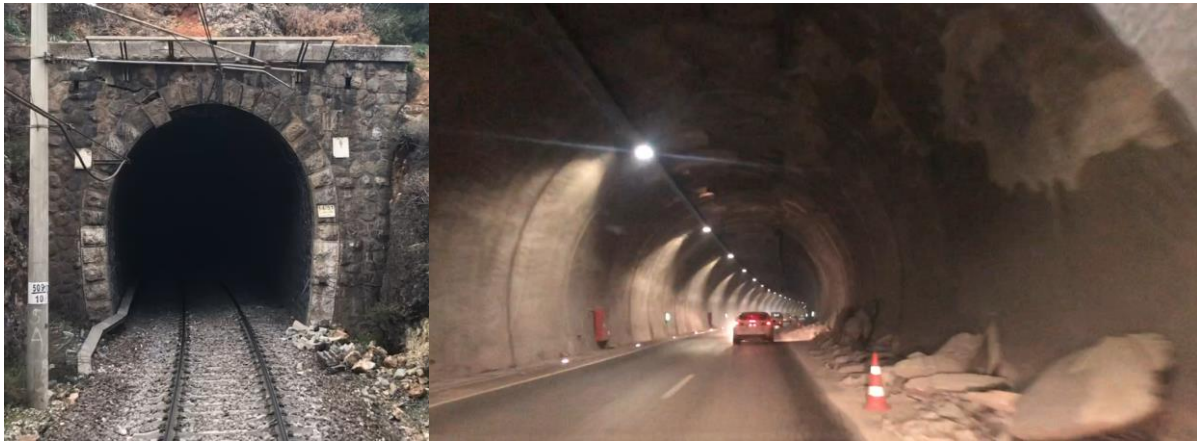
Figure 6.9. Tunnel portal movement and concrete spalling

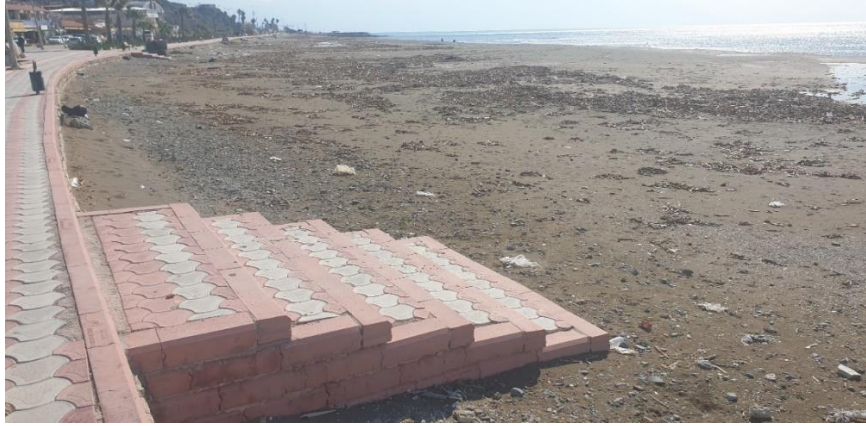
Figure 7.3 Coastal Inundation and traces, South of Samandağ-Çevlik Fishery Port

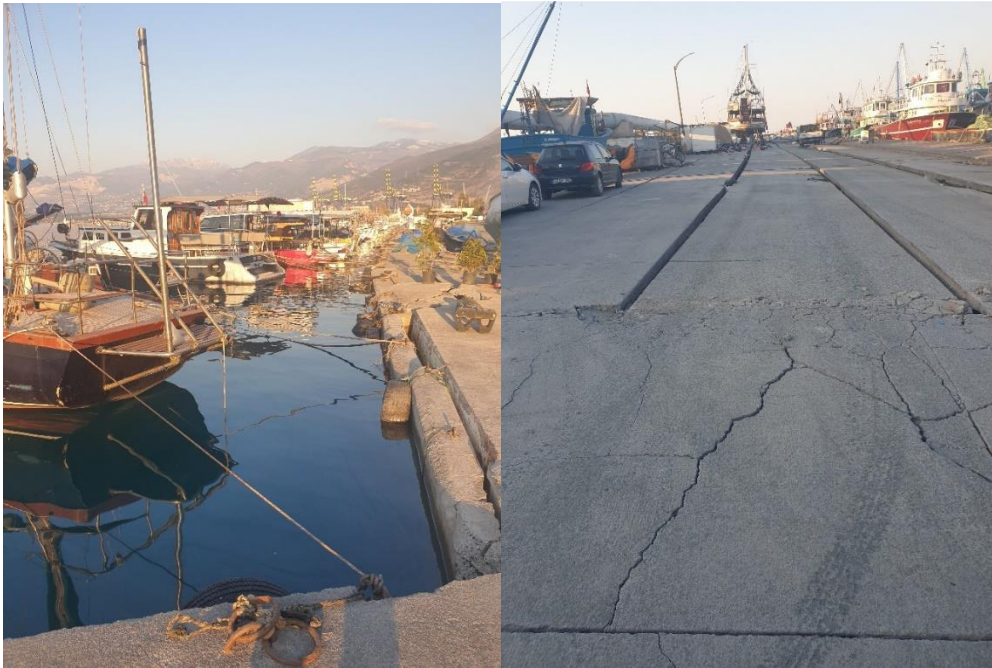
Figure 7.4 Structural damage at İskenderun Fishery Port

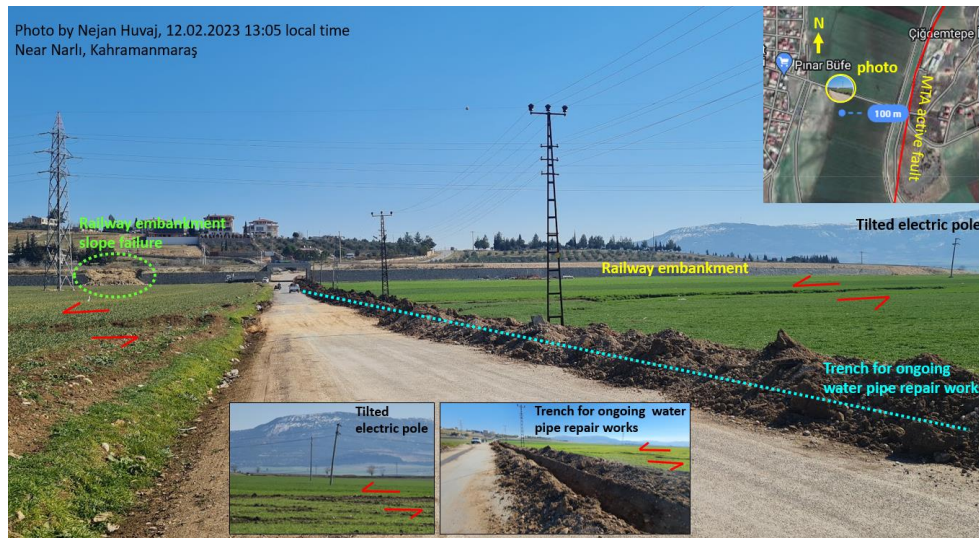
Figure 8.3. Referring to Figure 2 for locations of the photos: offset on the road due to surface fault rupture, railway embankment slope instability, water pipeline repair works and a tilted electric pole can be seen, near Narlı, Kahramanmaraş. (Active fault data is taken from Emre et al. (2013) published by the General Directorate of Mineral Research and Exploration, MTA (Maden Tetkik ve Arama Genel Müdürlüğü)).

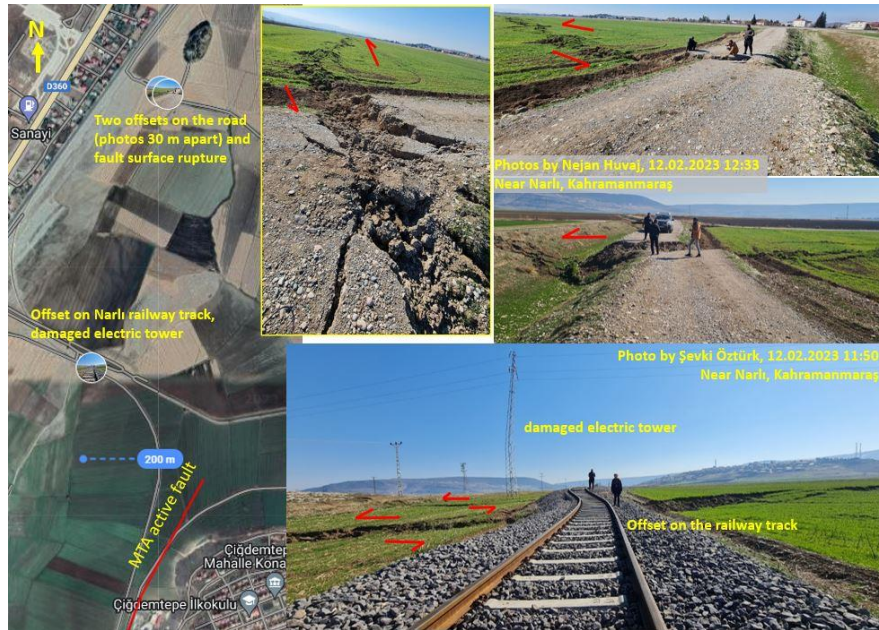
Figure 8.4. Surface rupture, offset, cracks and damages on railway tracks and roads, as well as a damaged electric tower, near the surface rupture (Narlı, Kahramanmaraş). (Active fault data is taken from Emre et al. (2013)).

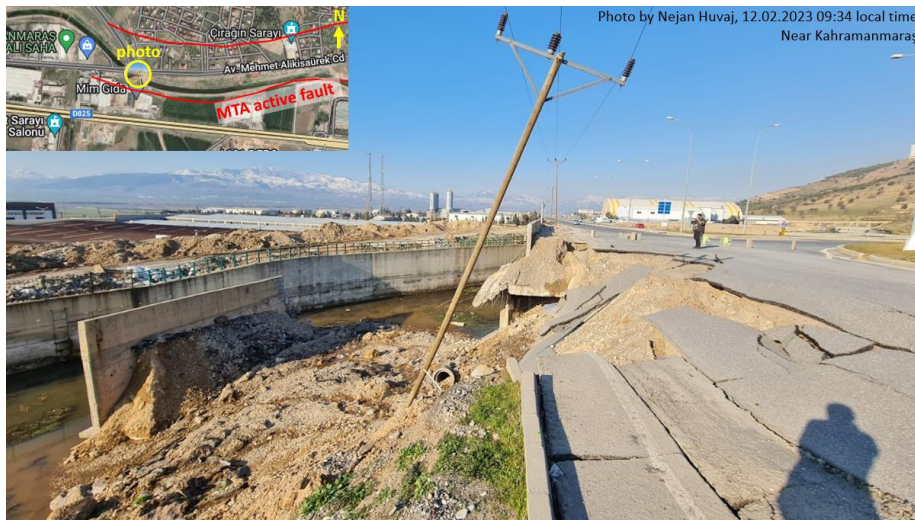
Figure 8.5. A landslide and crack/damages on the road next to a water canal, causing significant lateral displacement of a concrete retaining wall (pushed towards the water canal), a tilt on an electric pole, in southern part of the city of Kahramanmaraş (active fault data from Emre et al. (2013)).

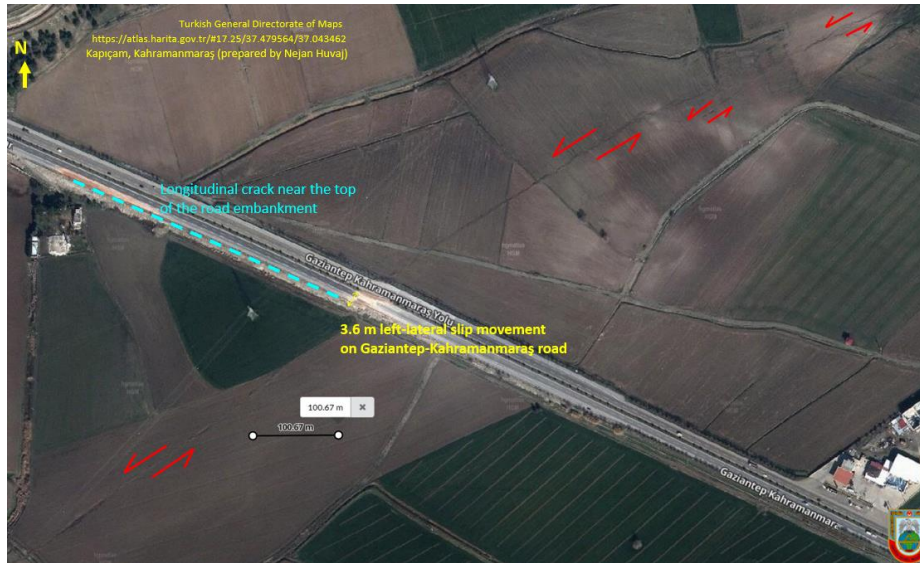
Figure 8.6. Surface rupture observations causing a 3.6 m offset on Gaziantep-Kahramanmaraş road, cracks on the asphalt road at several locations, road embankment instability and more than 250 m-long longitudinal cracks at the top of the road embankment as well as on the asphalt road, near Kıpıçam, Kahramanmaraş (Satellite images are provided by Turkish General Directorate of Maps via atlas.harita.gov.tr website)

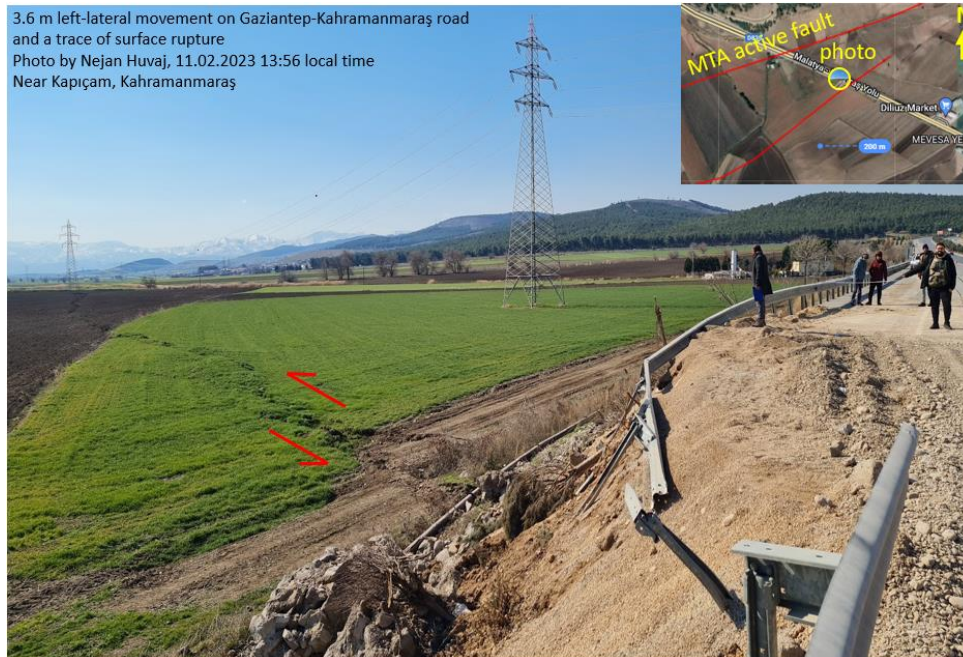
Figure 8.7. Referring to Figure 6 for the location: surface rupture observations and 3.6 m offset on Gaziantep-Kahramanmaraş road (active fault data from Emre et al. (2013)).

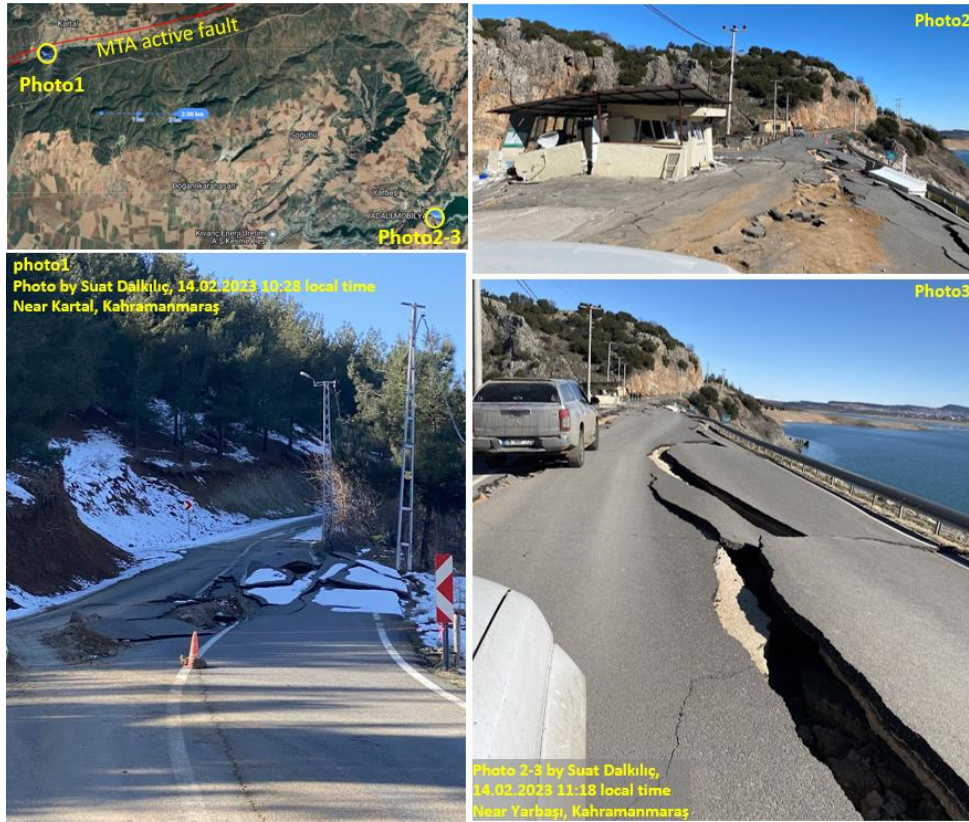
Figure 8.8. Landslides and surface cracks on the roads, near Kartal and Yarbaşı, Kahramanmaraş (Active fault data from Emre et al. (2013)).

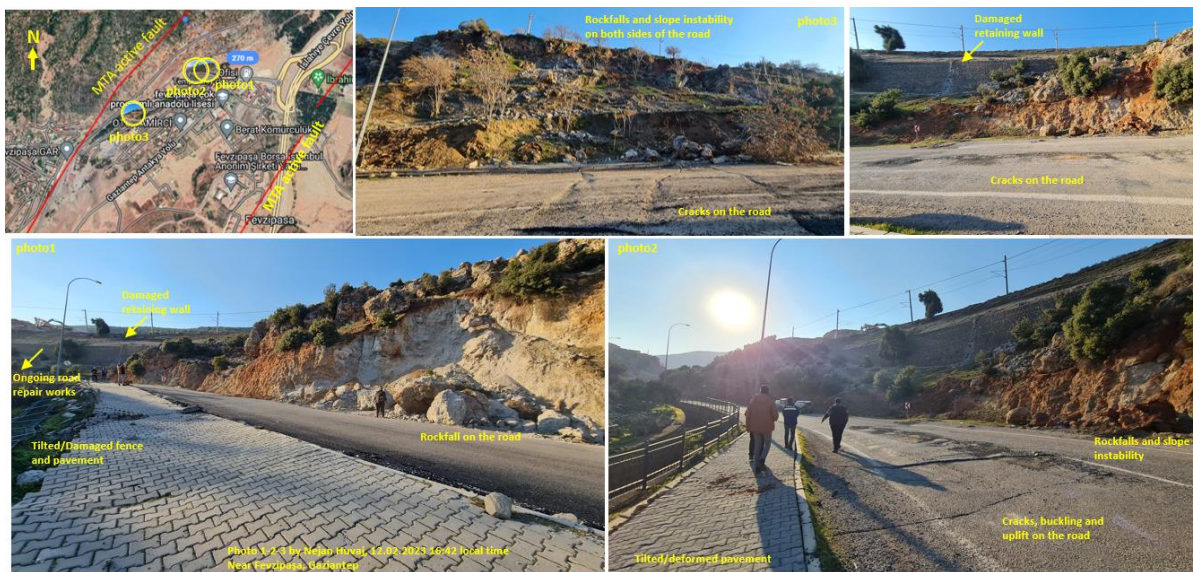
Figure 8.9. Landslides, rockfalls and surface cracks on the roads, near Fevzipaşa, Gaziantep causing disruption in the service (Active fault data from Emre et al. (2013)).
