MIDDLE EAST TECHNICAL UNIVERSITY

Preliminary Reconnaissance Report on February 6, 2023, Pazarcık $M_w=7.7$ and Elbistan $M_w=7.6$, Kahramanmaraş-Türkiye Earthquakes

REPORT NO: METU/EERC 2023-01

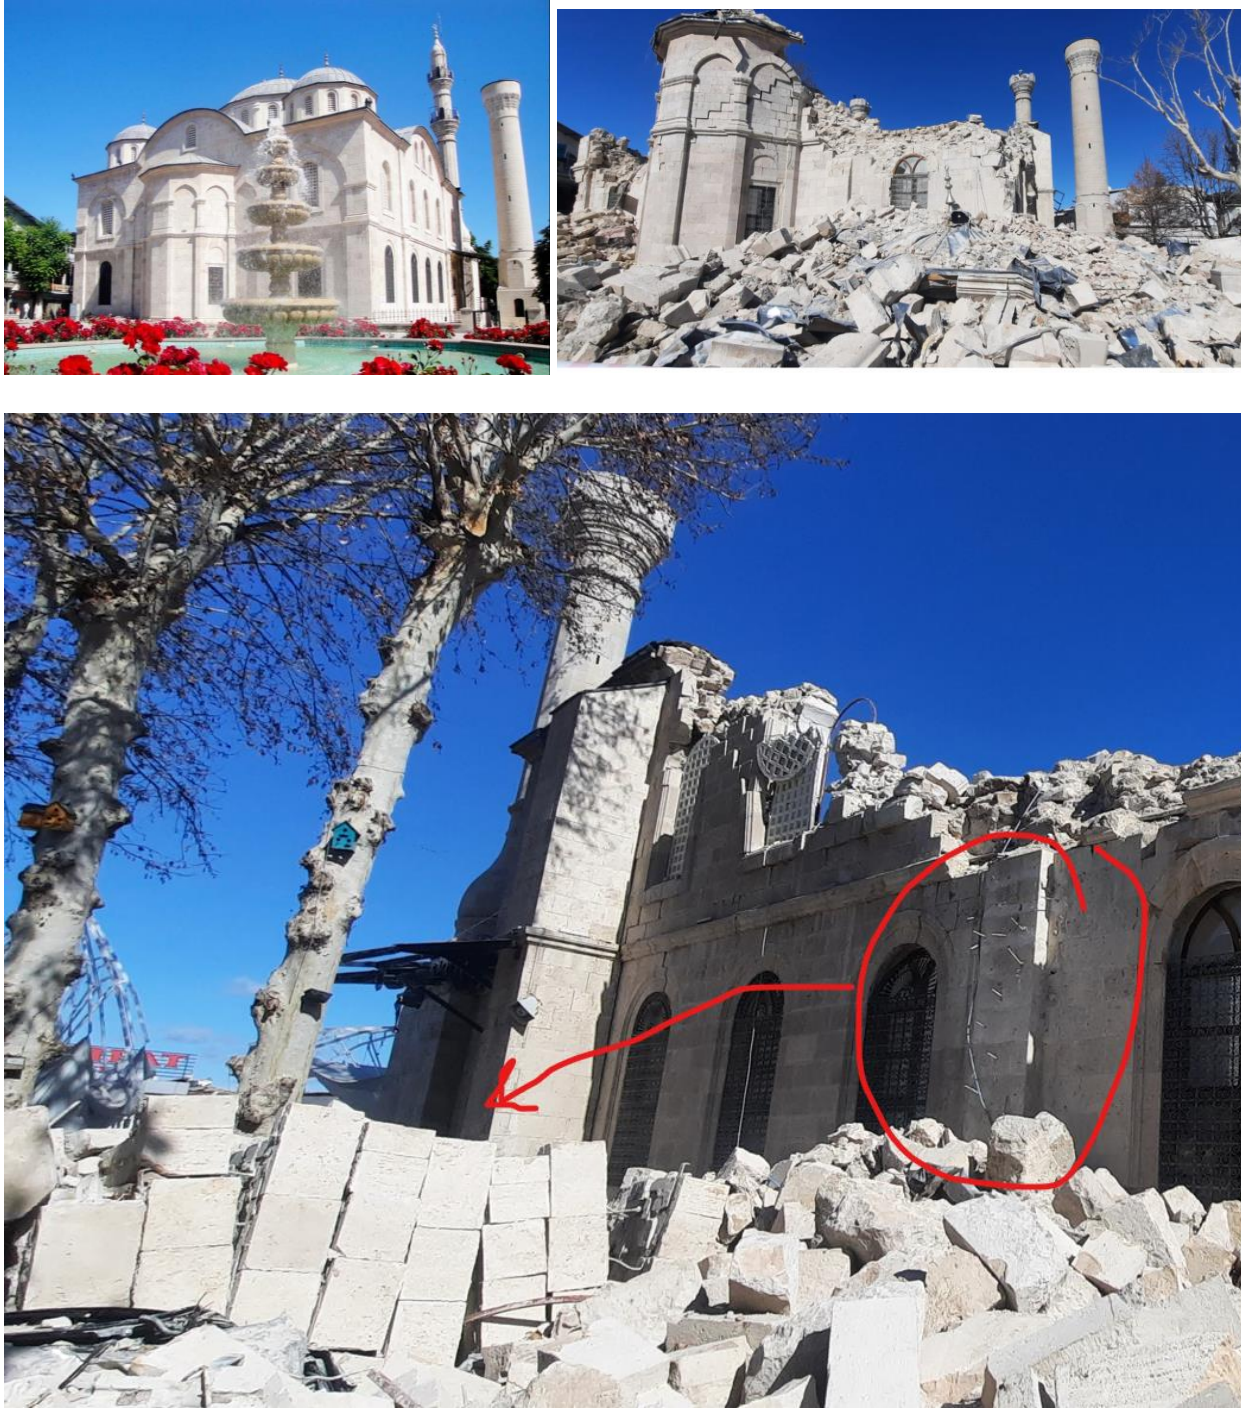
Figure 9.4 Yeni Cami (new mosque) before and after pictures and short anchorage.

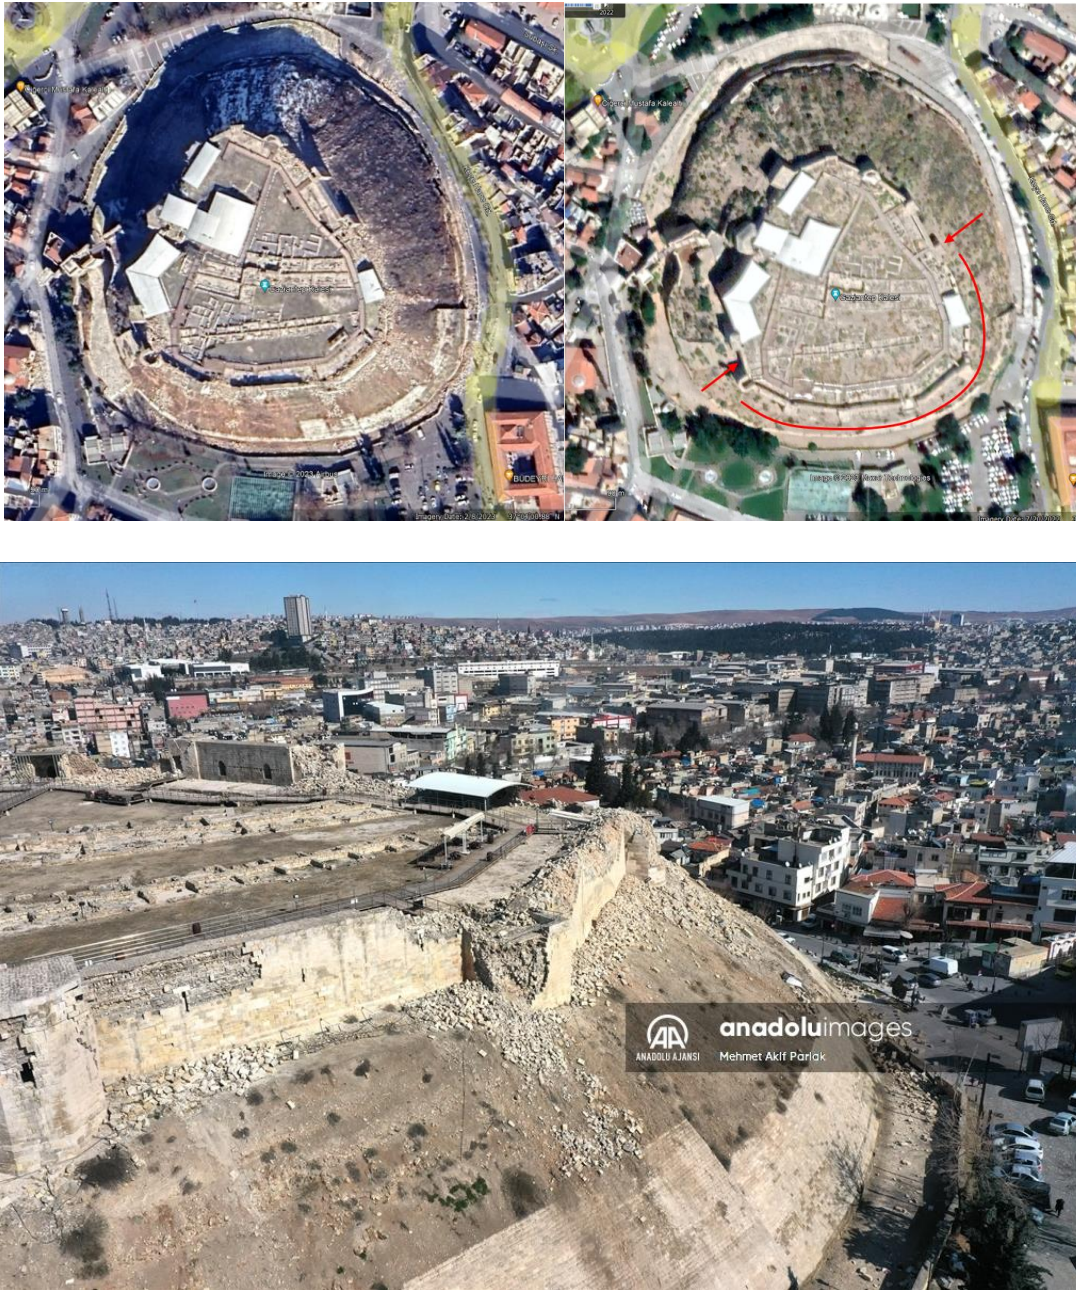
Figure 9.5 Gaziantep Castle before and after the earthquakes.

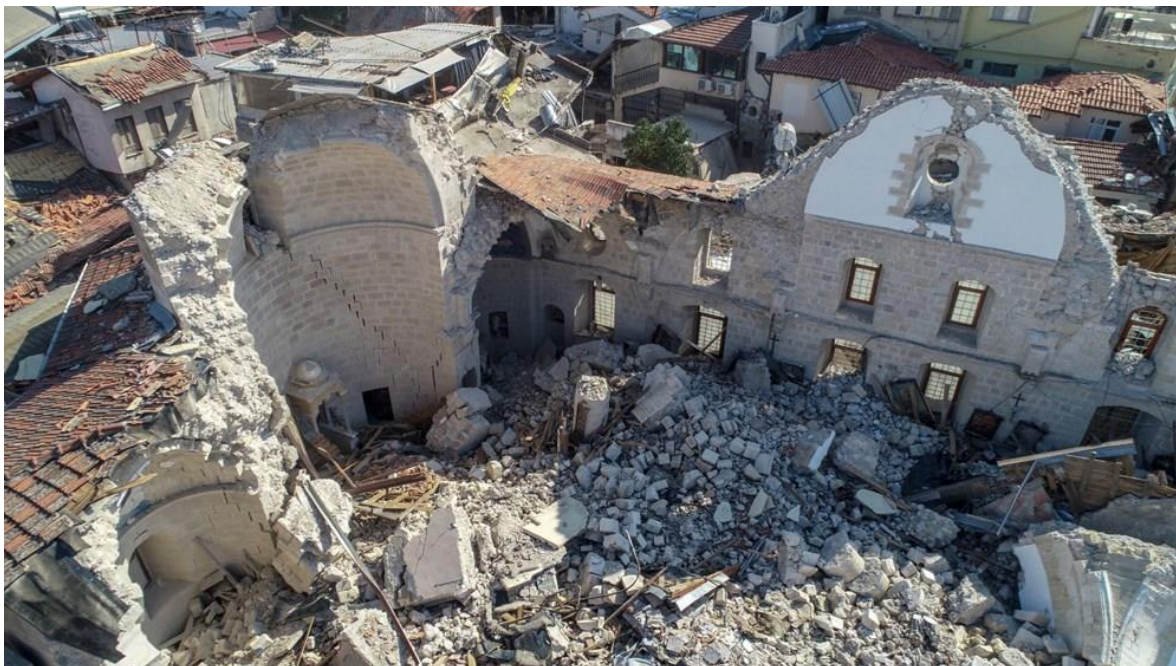
Figure 9.7 The Antakya Rum Orthodox Church after the earthquake ⁵

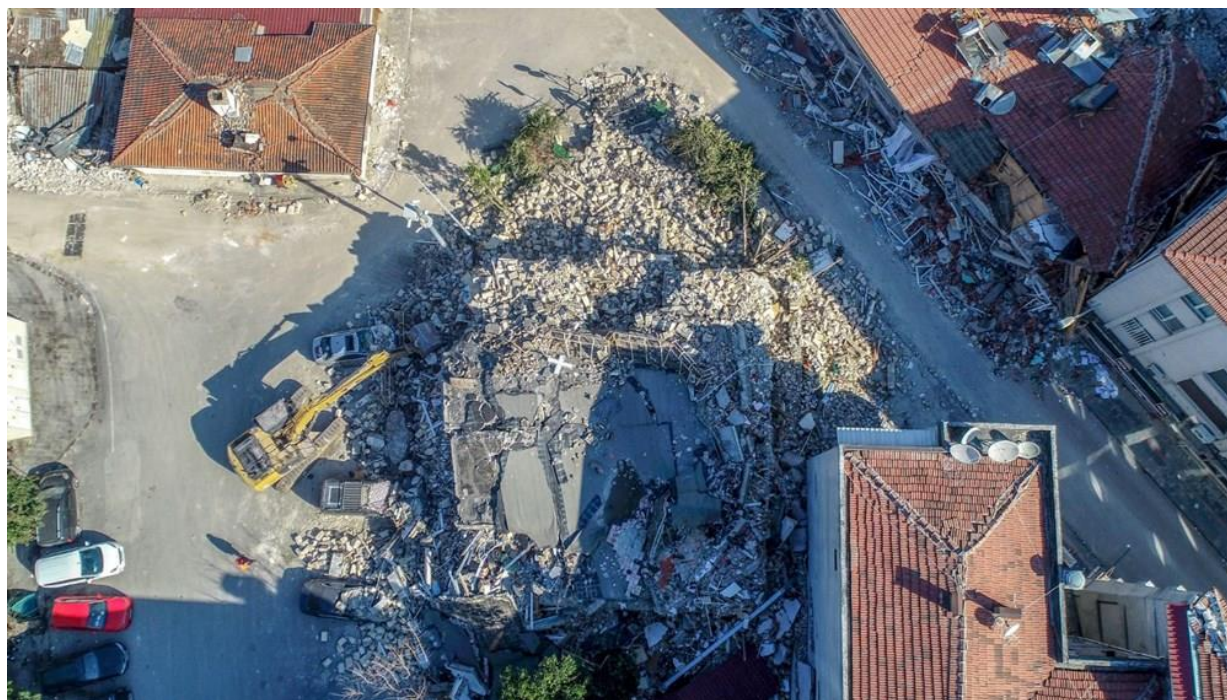
Figure 9.8 The Antakya Rum Protestant Church after the earthquake ⁶
