MIDDLE EAST TECHNICAL UNIVERSITY

Preliminary Reconnaissance Report on February 6, 2023, Pazarcık $M_w=7.7$ and Elbistan $M_w=7.6$, Kahramanmaraş-Türkiye Earthquakes

REPORT NO: METU/EERC 2023-01

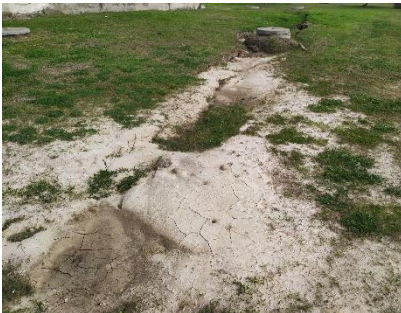
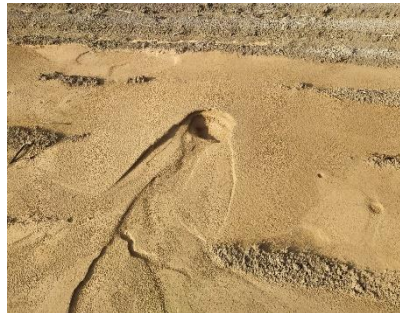
Seismic soil liquefaction-induced surface manifestations in the form of ejecta, lateral spreading, and subsidence were observed, as displayed in Figure 4.1 through Figure 4.3. Some of these manifestations were observed as in Figure 4.1 at free field sites. In addition to free field sites, liquefaction surface manifestations were also observed in the vicinity of building foundations. Figure 4.3 display the ejecta observed at the edges of residential building foundations.

Figure 4.1. Seismic soil liquefaction-induced surface manifestation: sand boils in free field conditions: **a)** Hatay ($36.36446^\circ N, 36.28147^\circ E$), **b)** Kumlu / Hatay ($36.35628^\circ N, 36.39360^\circ E$), **c)** Fatih District / Gölbaşı / Adıyaman ($37.78080^\circ N, 37.62888^\circ E$), **d)** İskenderun / Hatay ($36.59323^\circ N, 36.18542^\circ E$), **e)** Emiroğlu / Kahramanmaraş ($37.33689^\circ N, 37.04538^\circ E$), **f)** Çay District / İskenderun / Hatay ($36.59133^\circ N, 36.17888^\circ E$) **g)** Dört Yol / Hatay ($36.81878^\circ N, 37.17770^\circ E$) **h)** Emiroğlu / Kahramanmaraş ($37.33722^\circ N, 37.04549^\circ E$) **i)** Gölbaşı / Adıyaman ($37.78655^\circ N, 37.63155^\circ E$)

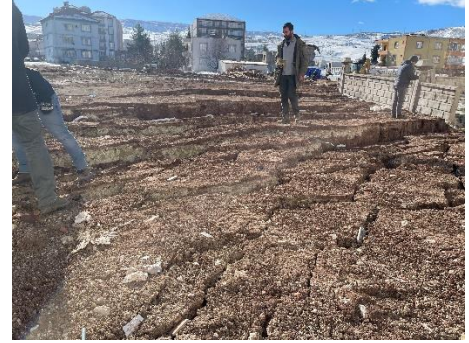
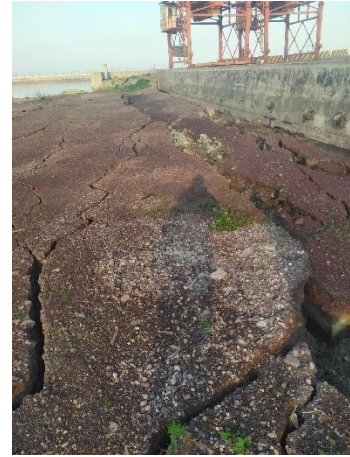
The liquefaction phenomena were widely observed in Hatay-Paşaköy, Hatay-İskenderun, Adıyaman-Gölbaşı, Adıyaman-Türkoğlu regions. Lateral spreading and subsidence were accompanied to liquefaction triggering at these sites.

Figure 4.2. Seismic soil liquefaction induced lateral spreadings in **a)** Çay District / İskenderun / Hatay ($36.59281^{\circ}N$, $36.185977^{\circ}E$), **b)** Özerli District / Dörtyol / Hatay ($36.81294^{\circ}N$, $36.18123^{\circ}E$), **c)** Fatih District / Gölbaşı / Adıyaman ($37.78023^{\circ}N$, $37.62858^{\circ}E$), **d)** İskenderun Port Area / Hatay ($36.59991^{\circ}N$, $36.19274^{\circ}E$), **e)** İskenderun Port Area / Hatay ($36.59991^{\circ}N$, $36.19274^{\circ}E$), **f)** İskenderun Port Area / Hatay ($36.59991^{\circ}N$, $36.19274^{\circ}E$).

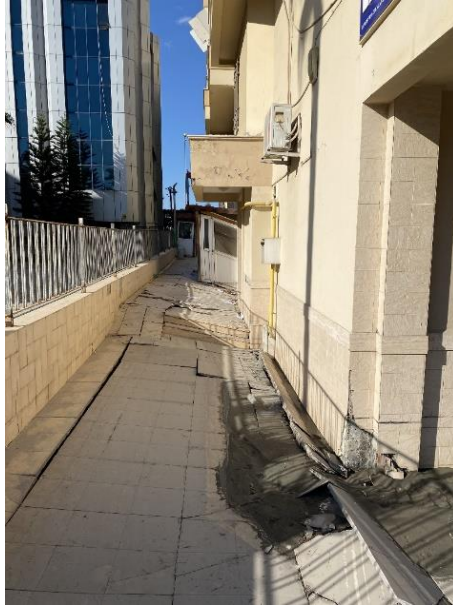
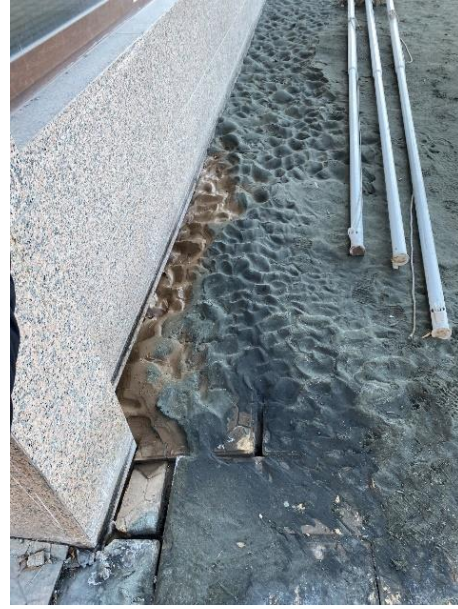
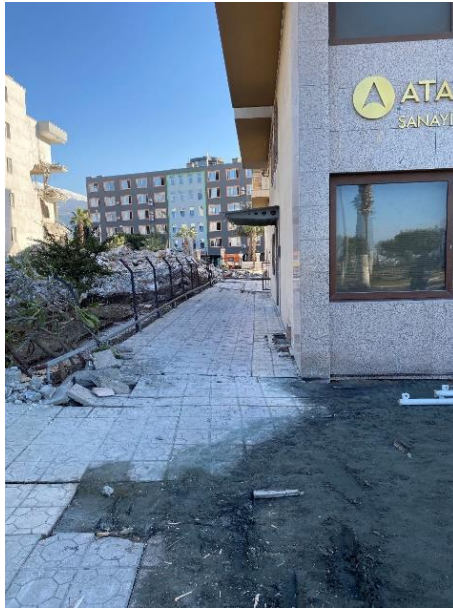
Figure 4.3. Seismic soil liquefaction-induced induced foundation problems in **a)** Çay District / İskenderun / Hatay ($36.5911^{\circ}N$, $36.1790^{\circ}E$), **b)** Çay District / İskenderun / Hatay ($36.5911^{\circ}N$, $36.1790^{\circ}E$), **c)** Çay District / İskenderun / Hatay ($36.5911^{\circ}N$, $36.1790^{\circ}E$), **d)** Çay District / İskenderun / Hatay ($36.5911^{\circ}N$, $36.1790^{\circ}E$)

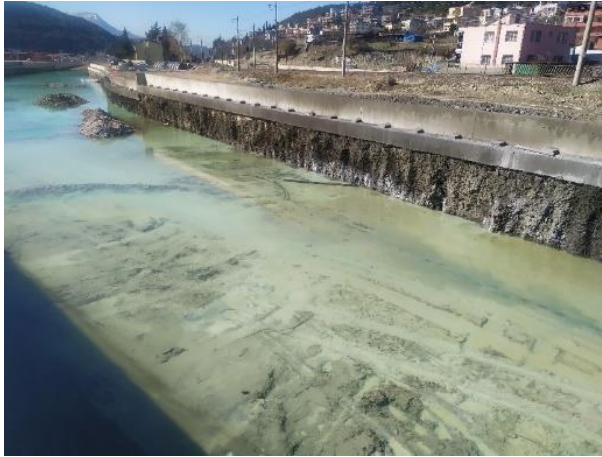
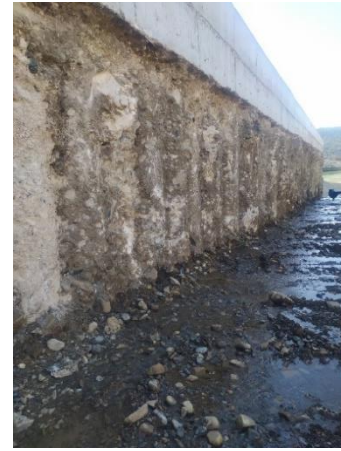
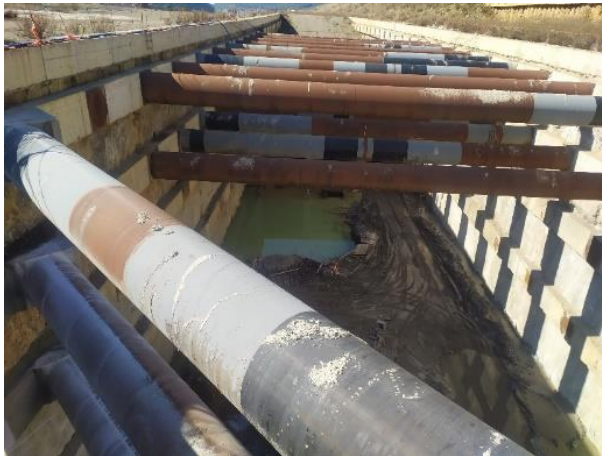
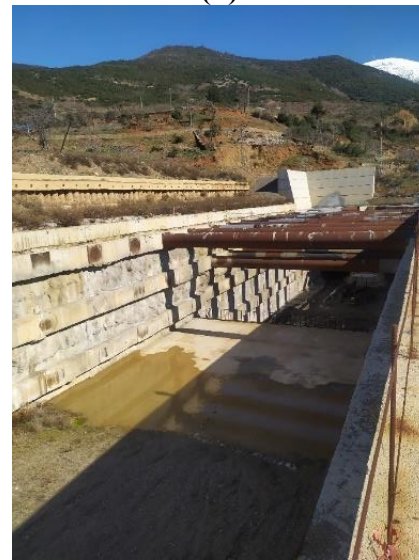
The performance of deep excavation systems on the route was also investigated. Figure 4.5 (a) and (b) display Osmaniye-Bahçe underpass, which was supported by cantilever reinforced concrete pile elements. No significant deformations were observed in the deep excavation support system. Next to the site, there exists a tunnel portal structure. Figures 4.5 (c) and (d) show the portal structure supported by reinforced concrete piles and strut elements.

Figure 4.5. Examples of deep excavations in **a)** Bahçe / Osmaniye ($37.18845^\circ N$, $36.56326^\circ E$), **b)** Bahçe / Osmaniye ($37.18939^\circ N$, $36.56402^\circ E$), **c)** Bahçe / Osmaniye ($36.17313^\circ N$, $36.59912^\circ E$), **d)** Bahçe / Osmaniye ($36.17313^\circ N$, $36.59912^\circ E$)

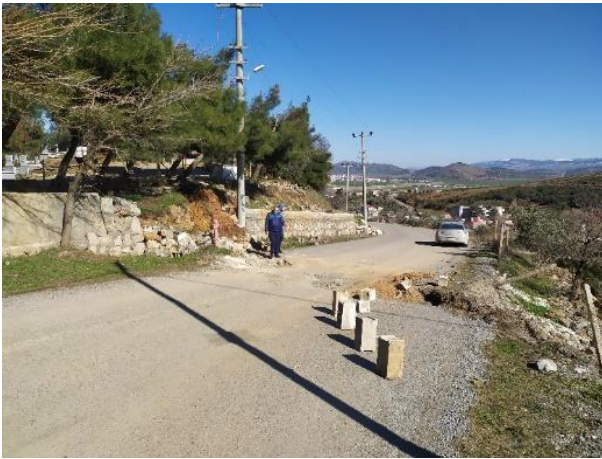
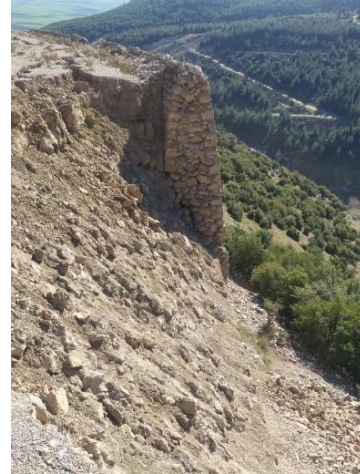
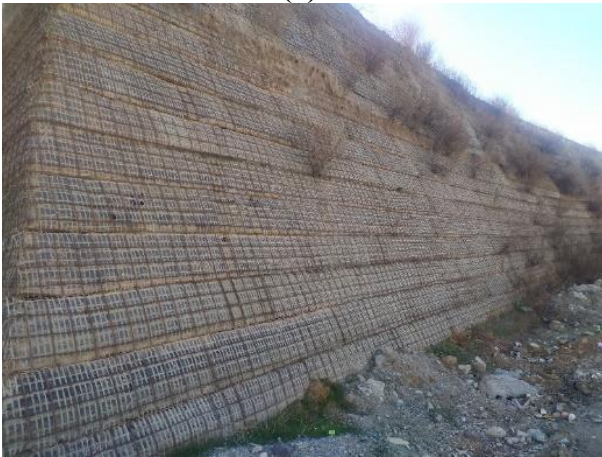
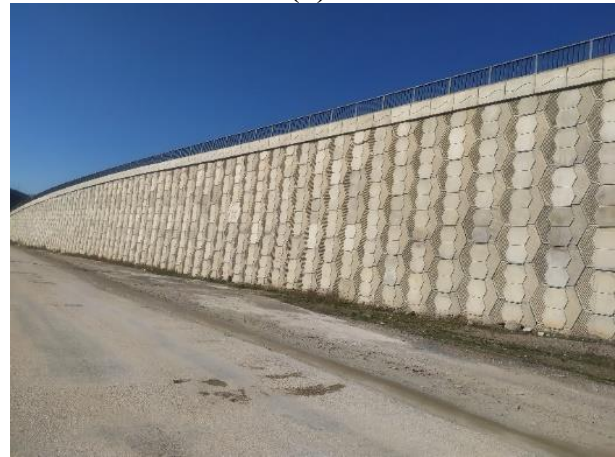
A limited number of tilted and/or partially collapsed and collapsed walls were also observed. Some stone walls supporting highway cuts and fills were deformed or fully collapsed as shown in Figures 4.6 (a) and (b). However, mechanically stabilized earth fill walls widely used as approach fills for bridges perform extremely well under peak ground acceleration levels in excess of 1 g in Fevzipaşa as shown in Figures 4.6 (c) and (d).

Figure 4.6. Some examples of retaining structures in **a)** Gökçedere/ Gaziantep ($37.16439^\circ N$, $36.70672^\circ E$), **b)** Gökçedere/ Gaziantep ($37.16546^\circ N$, $36.69749^\circ E$), **c)** Bahçe/ Osmaniye ($37.18853^\circ N$, $36.56389^\circ E$), **d)** Bahçe/ Osmaniye ($37.18844^\circ N$, $36.56476^\circ E$)

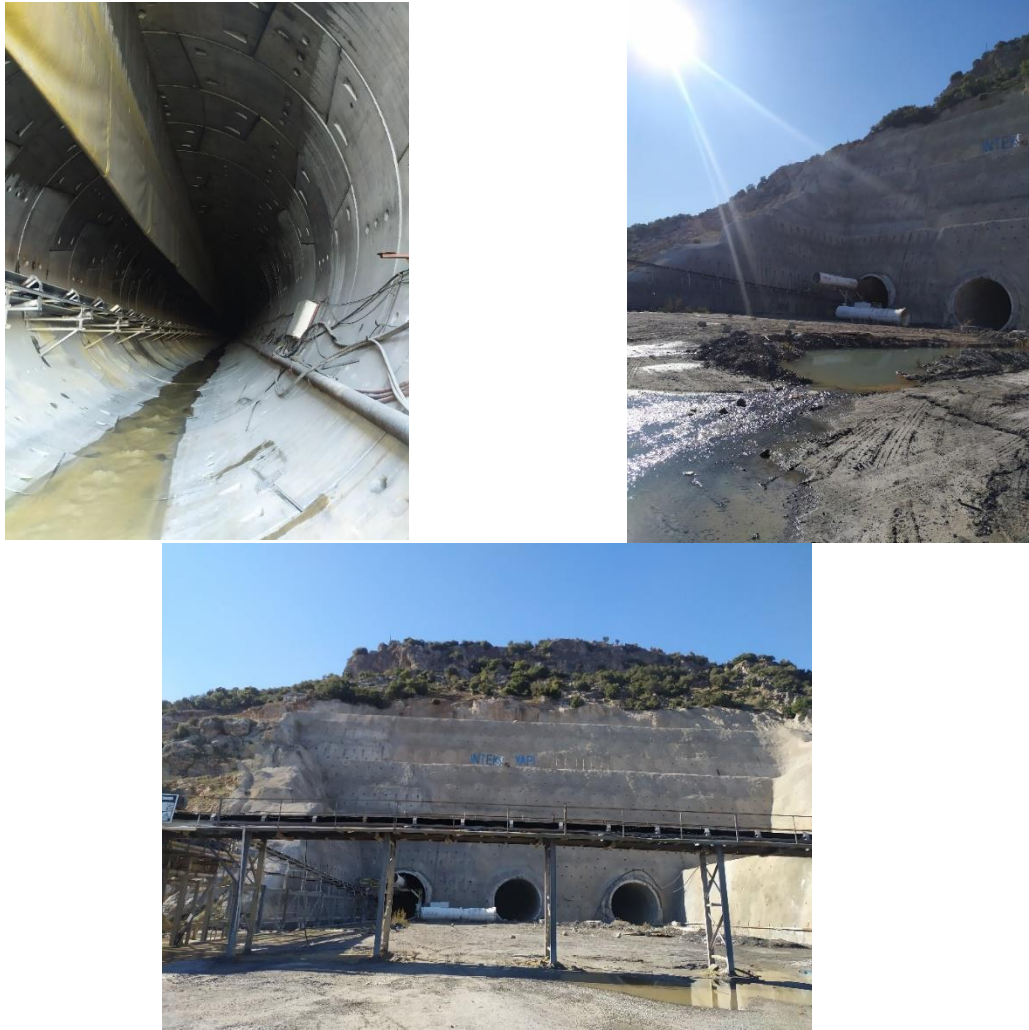
Tunnel structures in general performed well during and after the event. Except for minor damage observed in Erkenek tunnel lining, no major deformations were mapped. Some pictures from ongoing Bahçe-Nurdağ railway tunnel construction site are shown in Figure 4.8. The structural and geotechnical performance of them is reported to be superior. More about tunnels will be discussed in Chapter 6.

Figure 4.8. Bahçe-Nurdağı railway tunnels under construction in Nurdağı/ Gaziantep (37.16989°N, 36.70806°E)

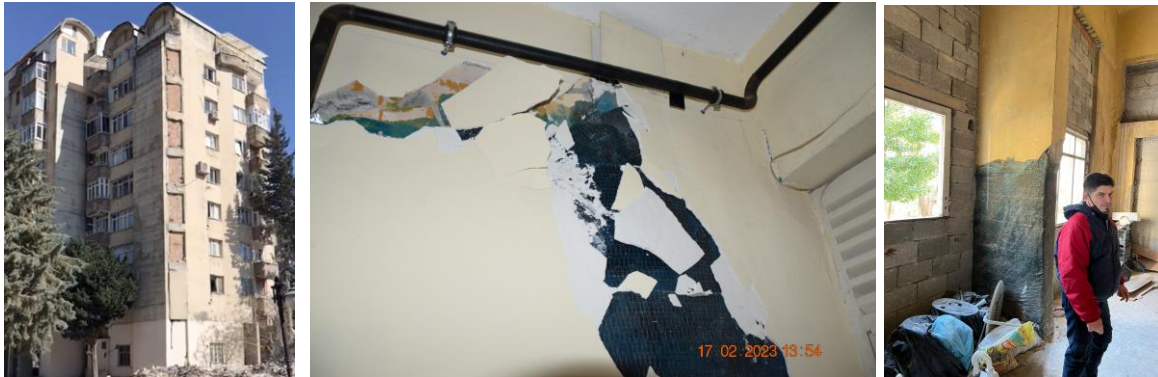
One building strengthened in 2008 by the METU team with the addition of shear walls, fiber reinforced polymers was visited in Hatay. None of the strengthened buildings collapsed while some damage was observed, as shown in Figure 5.10. These observations that will be extended in further site visits seem to encourage the wider spread application of building strengthening.

Figure 5.10. Performance of the strengthened building in Hatay

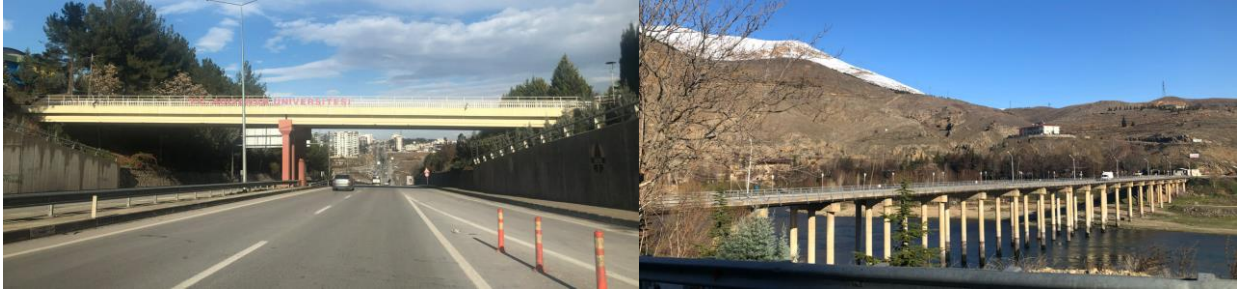
Figure 6.8. Bridge typical have no damage

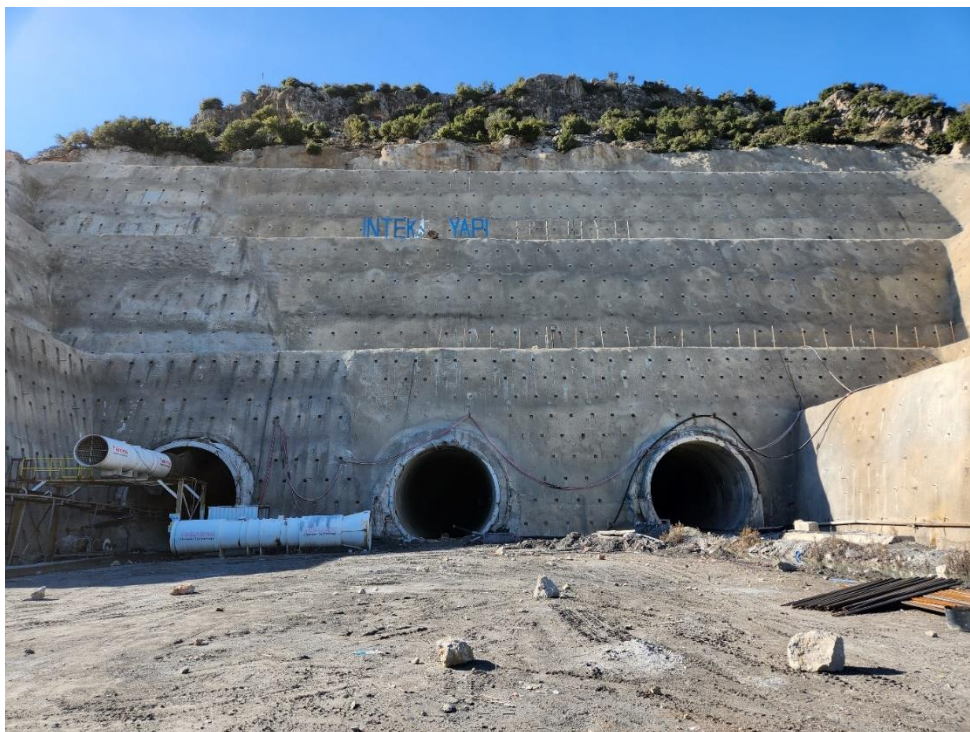
Figure 6.10. Nurdağı portal of Bahçe-Nurdağı railway tunnels

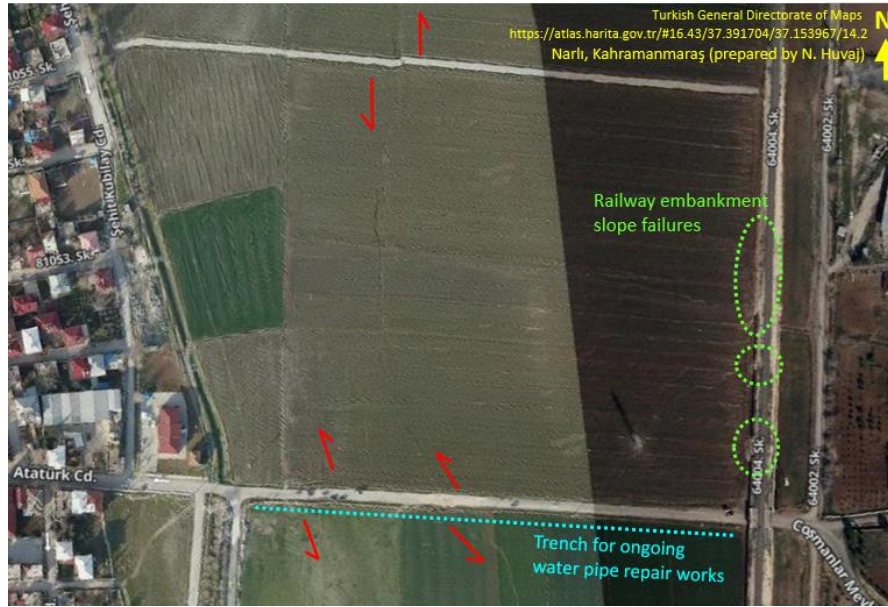
Figure 8.2. Areal view of the surface fault rupture and examples of damages caused by the two earthquakes on some of the lifelines: railway line, roads and water distribution network, near Narlı, Kahramanmaraş (Satellite images are provided by Turkish General Directorate of Maps via atlas.harita.gov.tr website)

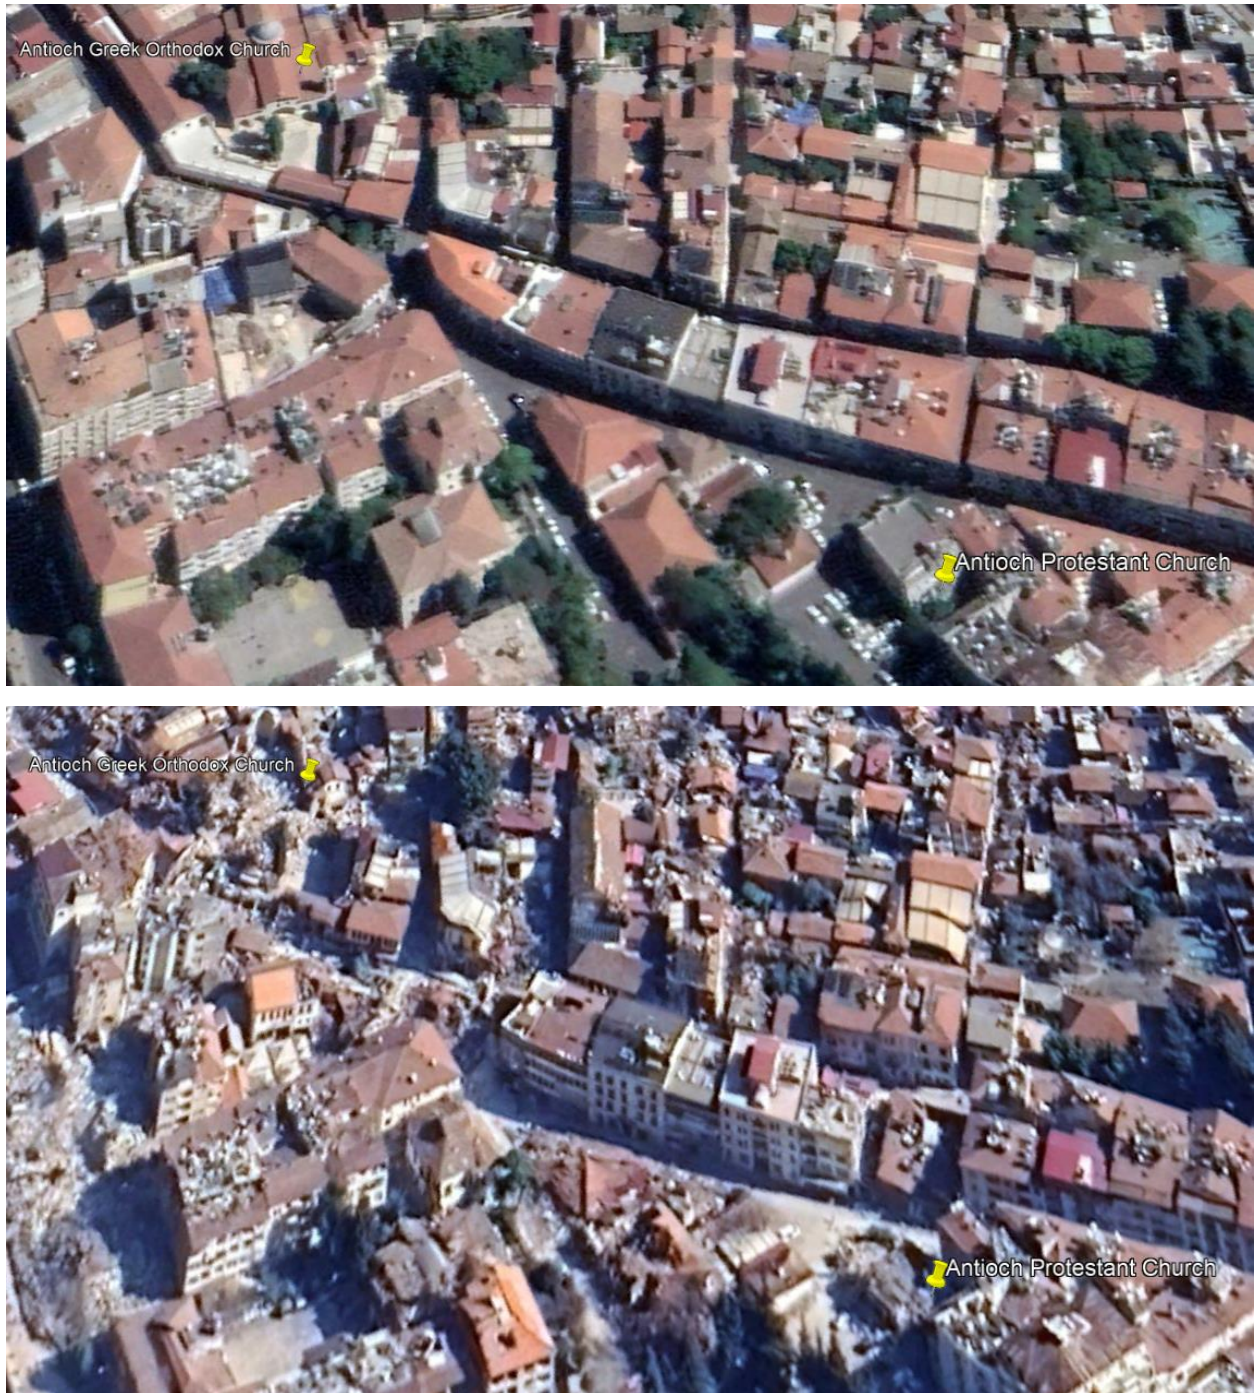
Last examples of historic structures were selected from Hatay region. The Antakya Rum Orthodox Church (Antioch Greek Orthodox Church) and Antakya Protestant Church are located very close to each other within 150 meters, and both suffered significant damage during the earthquakes. The distances between the churches and the first and second earthquakes are about 135 km and 225 km respectively. Satellite images before and after the earthquakes (**Figure 9.6.**)⁴ indicate that both structures suffered immense damage. The after-earthquake picture of the Antakya Rum Orthodox Church (**Figure 9.7.**) shows total roof collapse while only west wall and partial south cylindrical walls are standing. The collapsed picture of the Antakya Rum Orthodox Church also shows roof collapse with probably south wall collapse. The epicenter to the historic structures distances is comparable between Malatya and Hatay, both cities with significant damage to their historic buildings. Majority of the mosques showed acceptable performance in Malatya (exception of Yeni Cami) while both studied churches suffered major damage in Hatay.

Figure 9.6 The Antakya Rum Orthodox and Protestant Churches before and after earthquakes
